### March 20, 2019

# GRUENING MIDDLE SCHOOL POST-EARTHQUAKE ASSESSMENTS AND EVALUATION

Prepared For: Anchorage School District Facilities Department 1301 Labar Street Anchorage, Alaska 99515

<u>Prepared By:</u> BDS Architects 3330 C Street, Suite 200 Anchorage, Alaska 99503

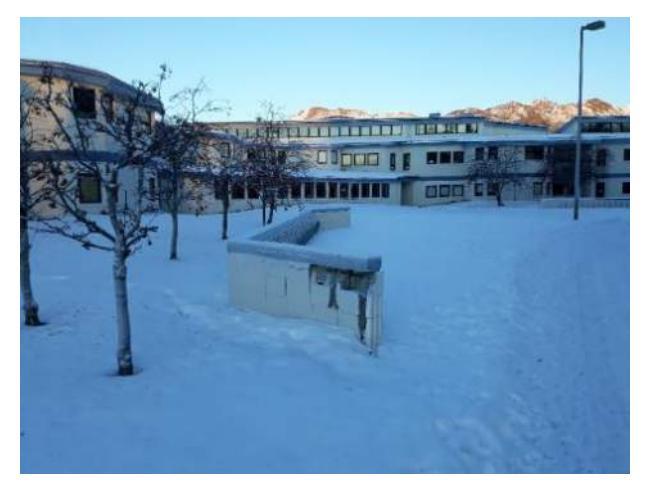
Photo 1-1: Damaged CMU at Bike Rack

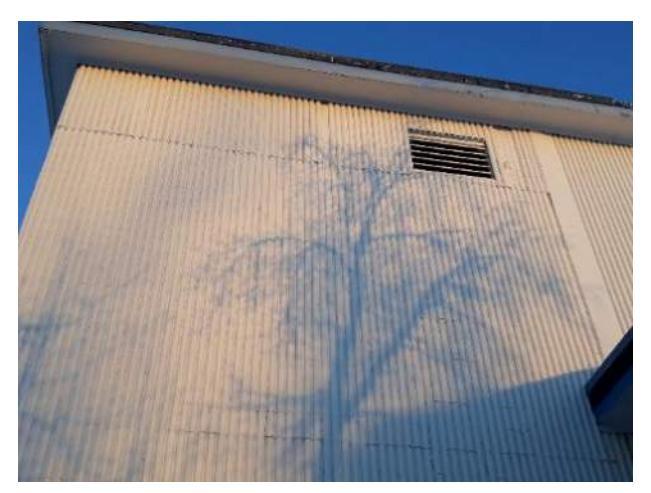
Photo 1-3: CMU Wall at South MPR

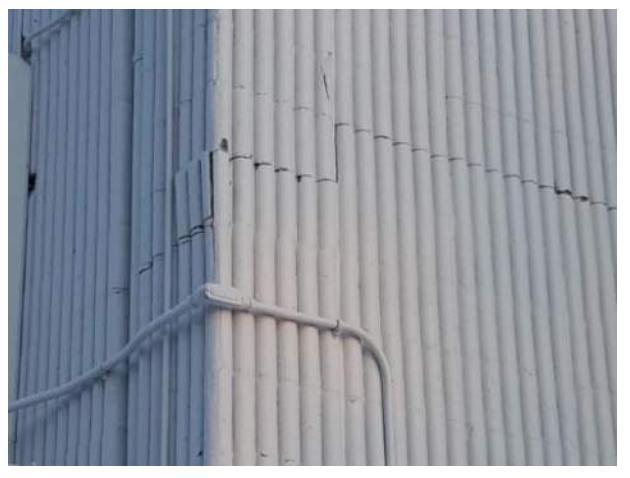
Photo 1-2: Damaged CMU at West MPR Wall

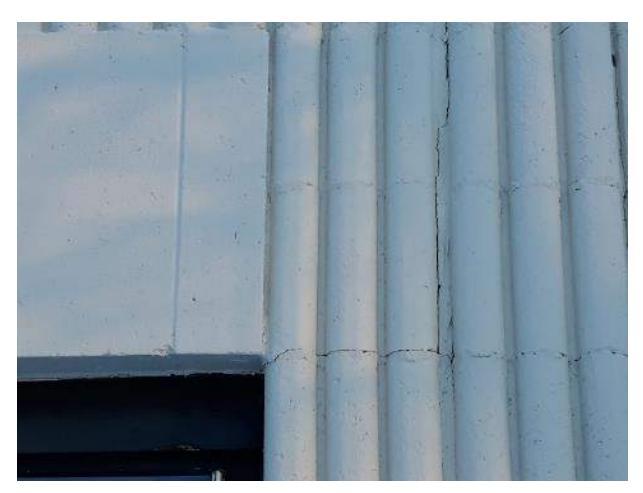
Photo 1-4: CMU Cracks at Door Header

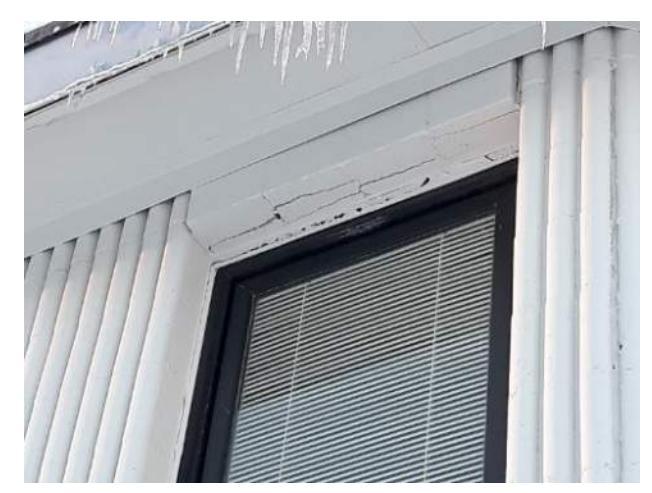
Photo 1-6: Cracked CMU Header at Classroom

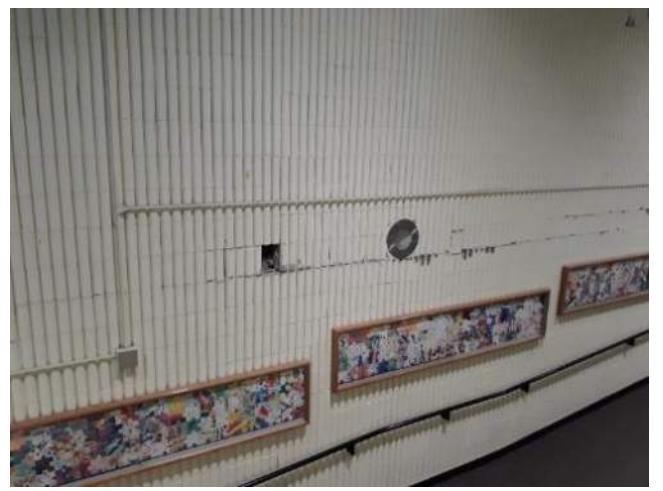
Photo 2-1: Damaged CMU at Corridor/Gym Wall

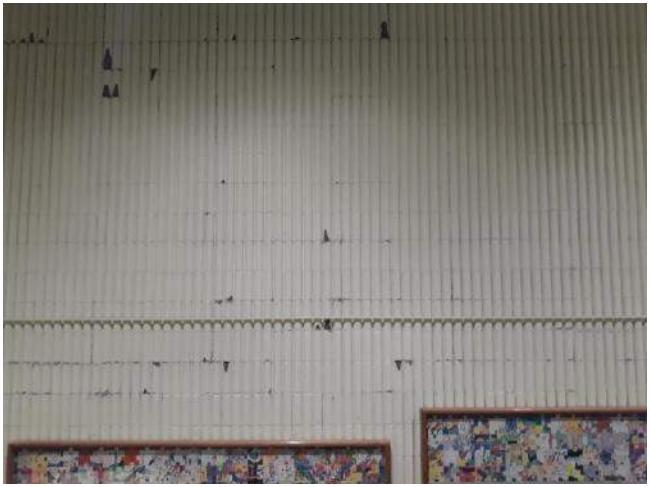
Photo 2-1: Damaged CMU at Corridor outside Gym

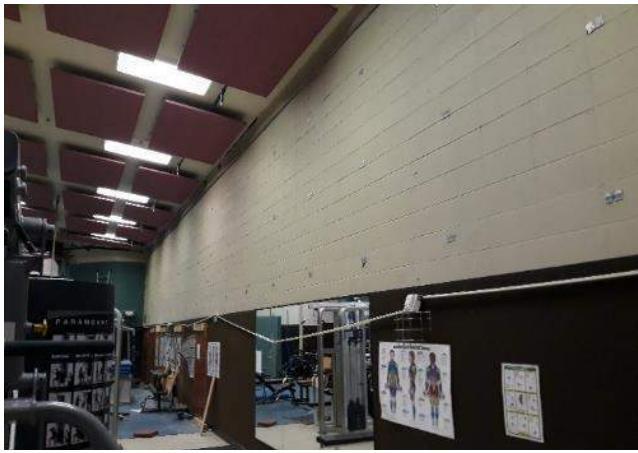
Photo 2-3: Displaced CMU Gym Wall at Weight Room

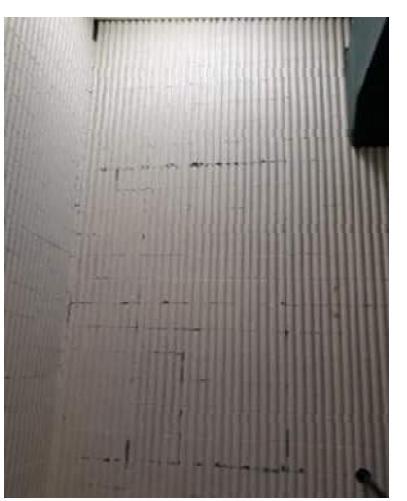
Photo A1-2: Damaged CMU Wall at Stairwell

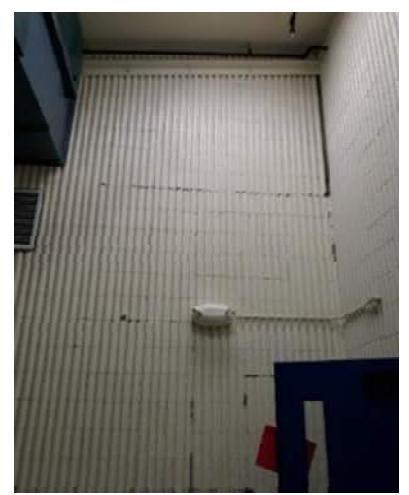
Photo A1-3: Damaged CMU at Gym Stair Landing

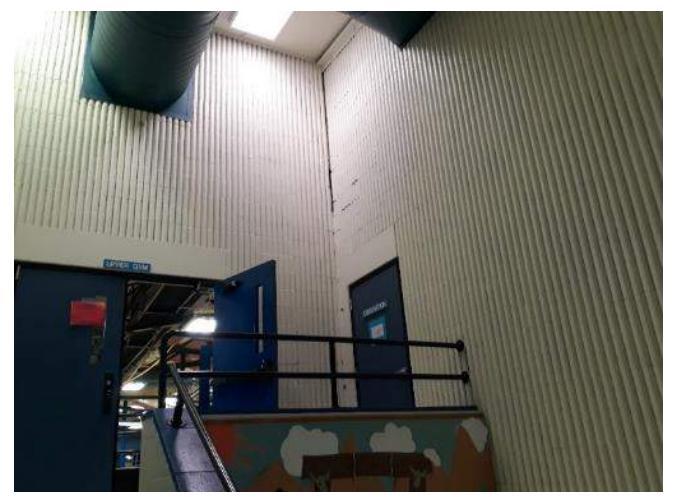
Photo A1-4: Damaged CMU at Gym Stair Landing

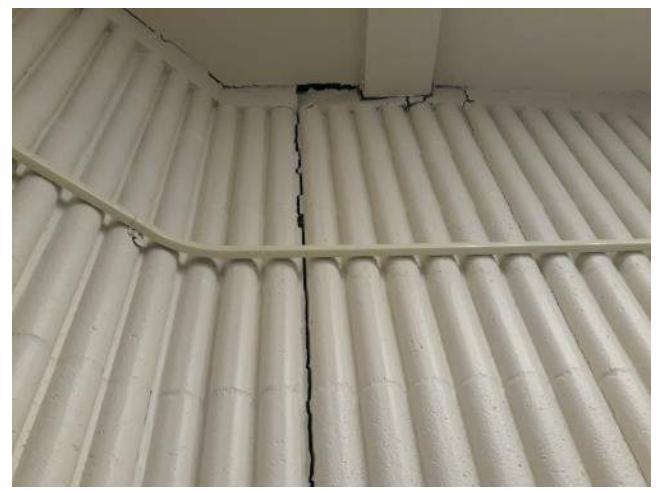
**General:** Doors and door frames appear to have performed well. Only the door pair located at the upper landing of stairwell SW2 has racked doors likely caused by the earthquake damage to this part of the structure. This door remains functional, although the door is not square to the mounting frame and floor.

Photo 3-1: Damaged CMU Wall at Stairwell SW 2

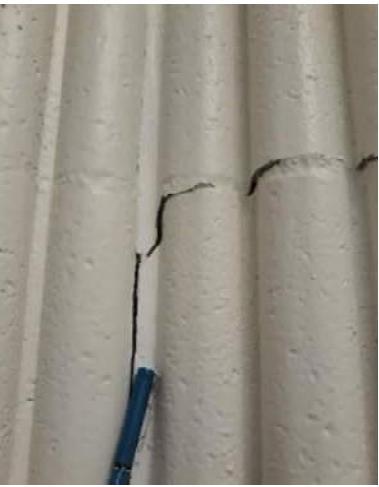
Photo A3-2: CMU Displacement at Stairwell SW 2

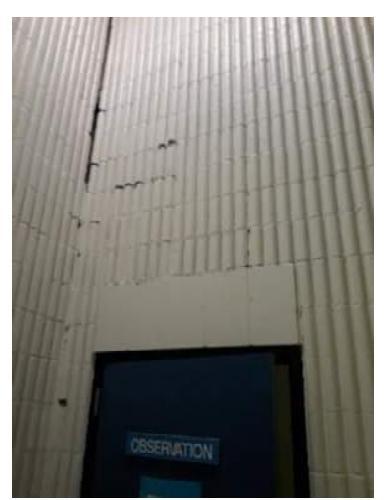
Photo 3-5: Damaged CMU at Stairwell landing

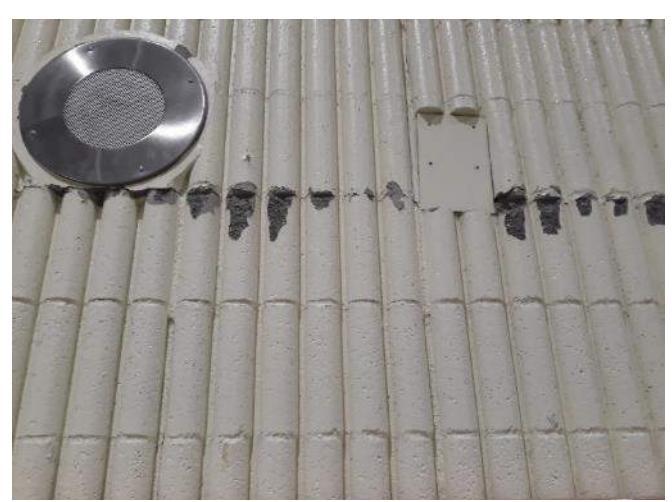
Photo A3-4: Typical CMU Spalling and Crack Damage

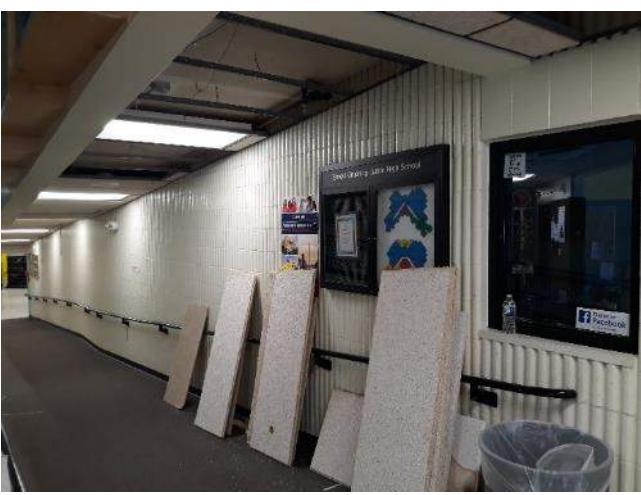
Photo 3-6: Corridor Tectum Ceiling Damage

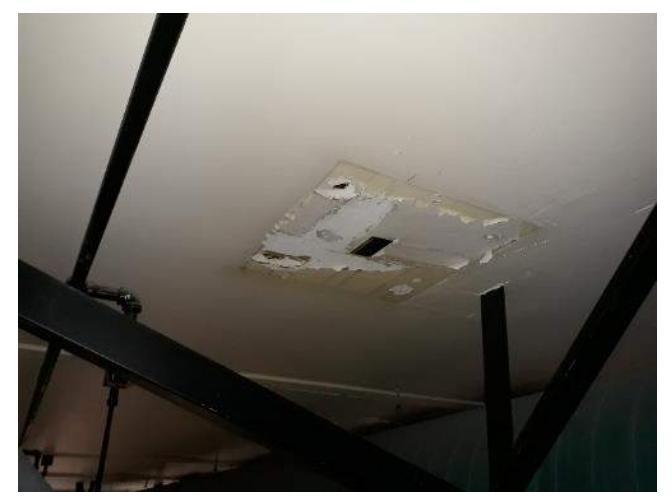
Photo 4-1: Gym Ceiling Damage

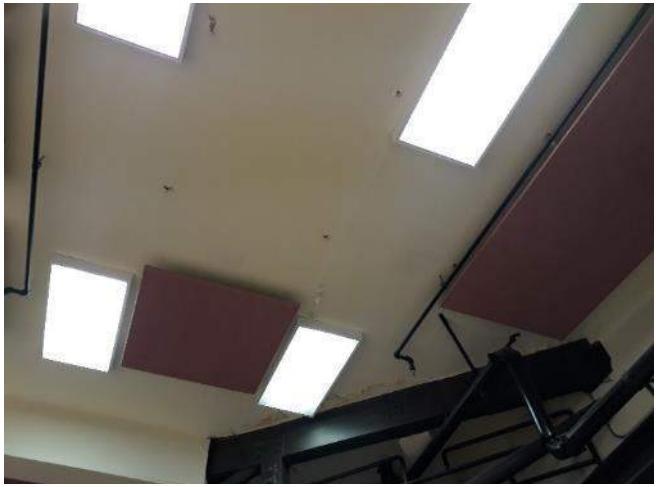
Photo 4-2: Fallen Acoustical Panel in Gym Area

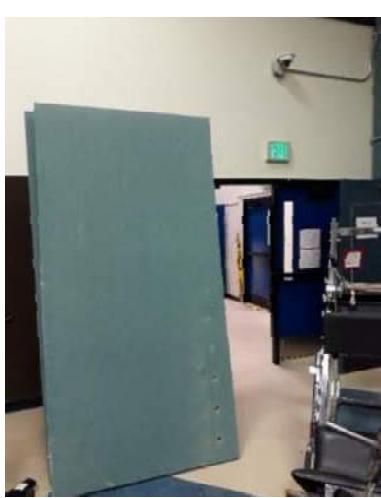
Photo 4-3: Damaged Acoustic Panel in Gym Area

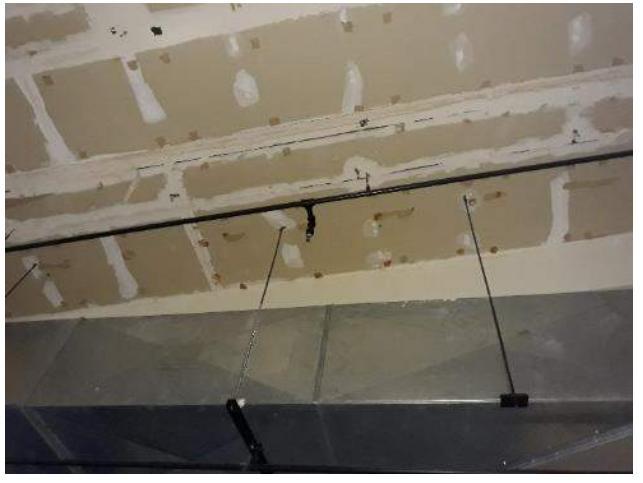
Photo 4-4: Broken GWB Fire-Tape Joints at Wrestling

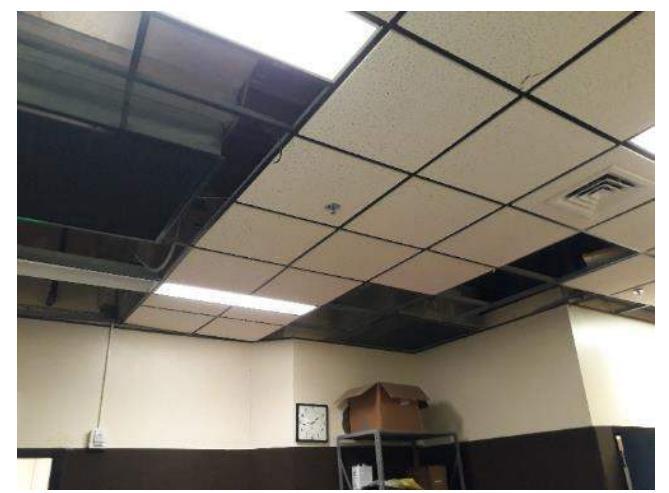
Photo 4-5: Damaged Ceiling in Room 224

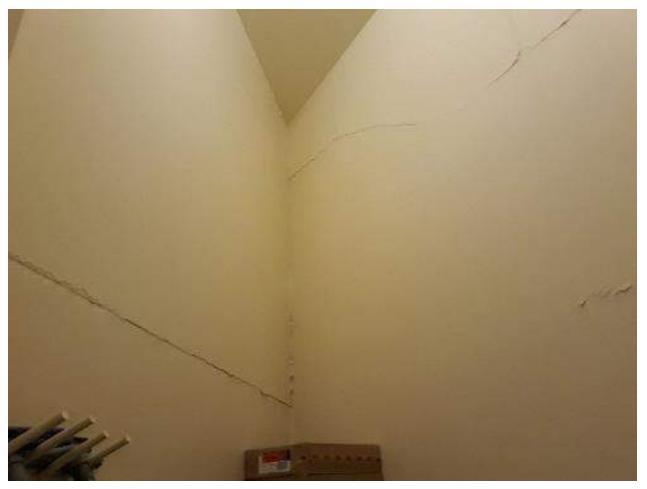
Photo 4-6: GWB Cracking, typical throughout

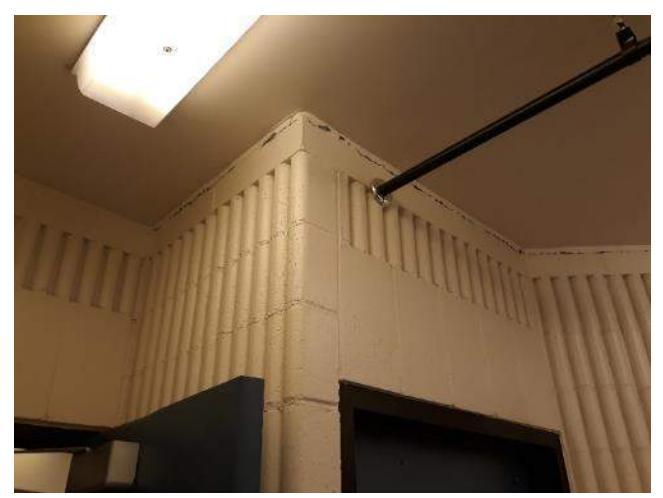
Photo 5-1: CMU Cracking at Top of Wall

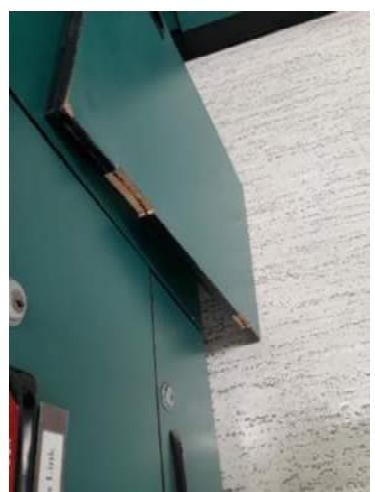
Photo 5-3: Damaged Cabinets in Room 15

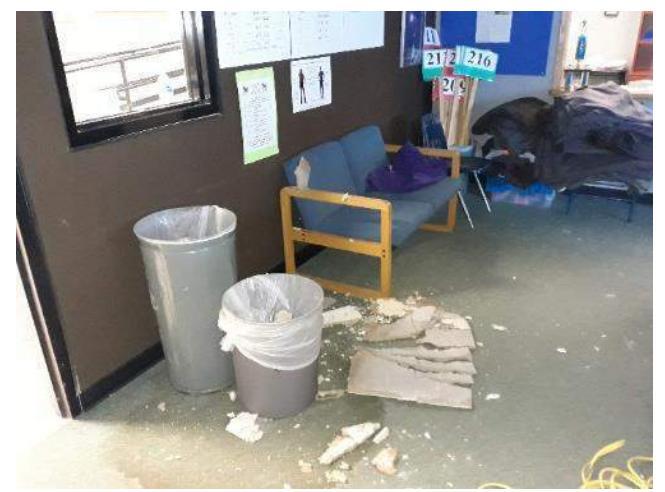
The roof was covered with snow and not inspected at the post-earthquake site visits. However, one recent leak was documented at the 1/8/19 site visit. This leak was in the east end of the administrative area, room 2. The construction contractor providing initial building stabilization and repairs, Eklutna Construction & Maintenance, documented this leak and initiated initial repairs provided by Rain Proof Roofing (Exhibit H). Temporary repairs were made on or about 1/7/2019. This was a new leak considered to be a direct result of the earthquake.

Photo 5-2: Roof Leak in Room 2

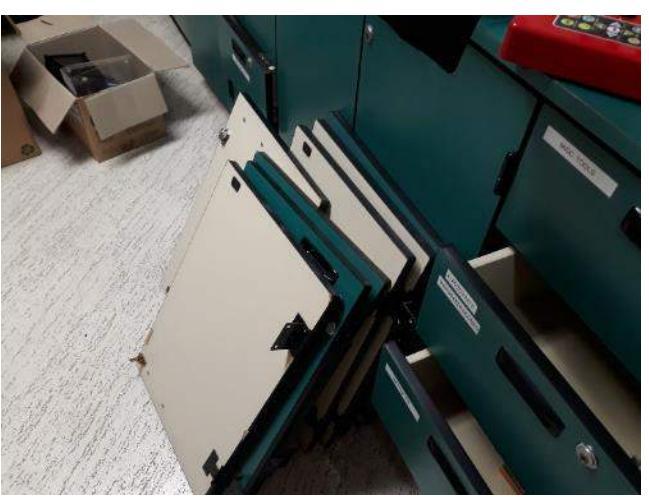
Photo 5-14: Damaged Cabinets in Room 11

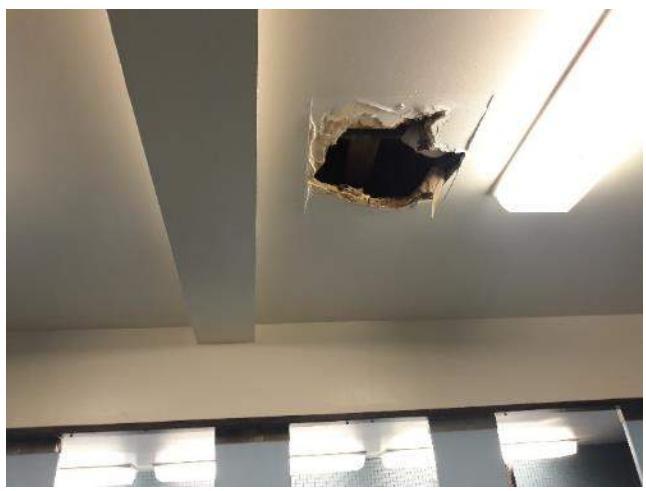
Photo 5-5: Damaged Ceiling in Room 17

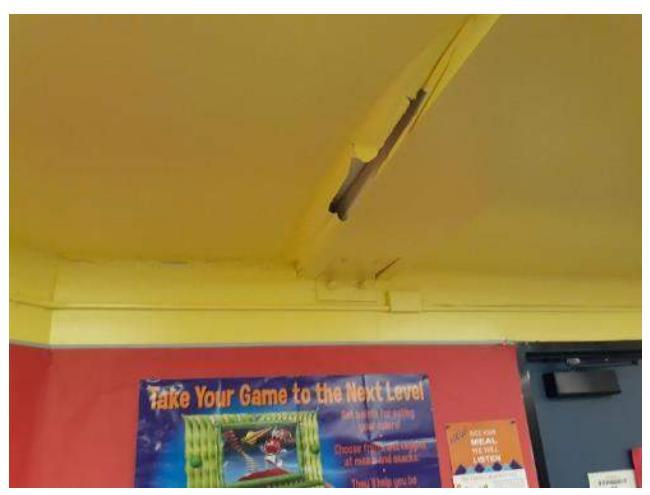
Photo 5-6: Ceiling Damage Kitchen, Typical this Area

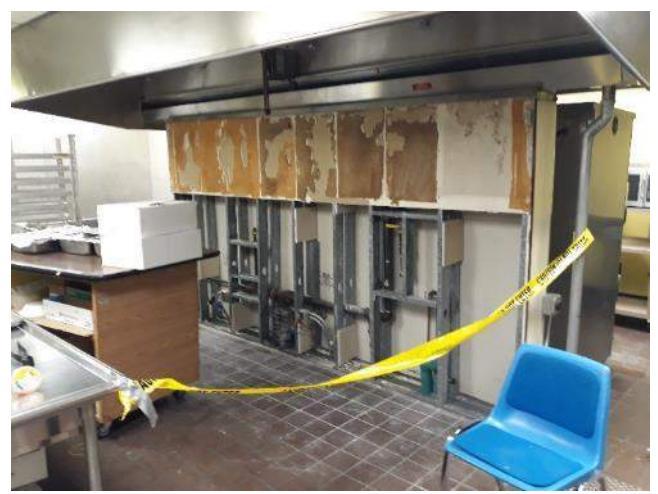
Photo 6-1: Damaged Kitchen Wall

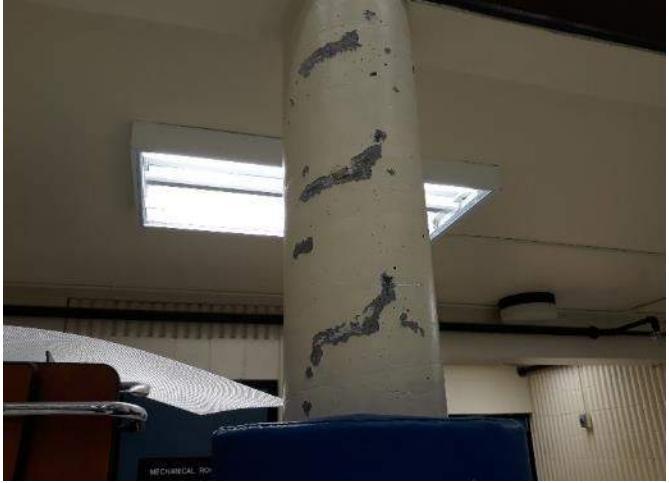
Photo 6-2: Damaged Column at MPR

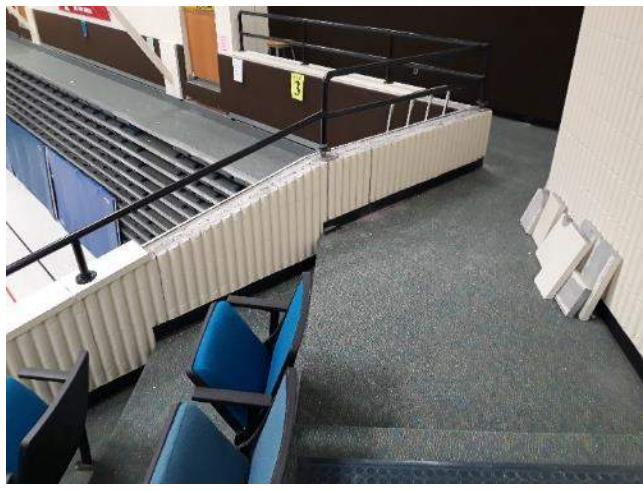
Photo 6-3: Damaged CMU Balcony Rail at MPR

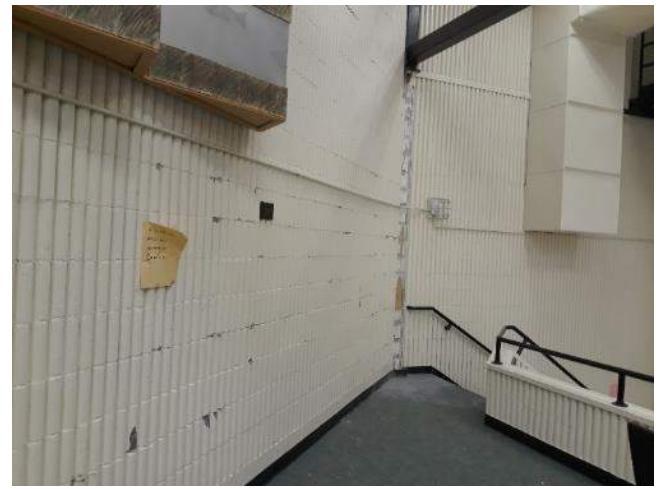
Photo 6-4: CMU Damage at MPR Mezzanine

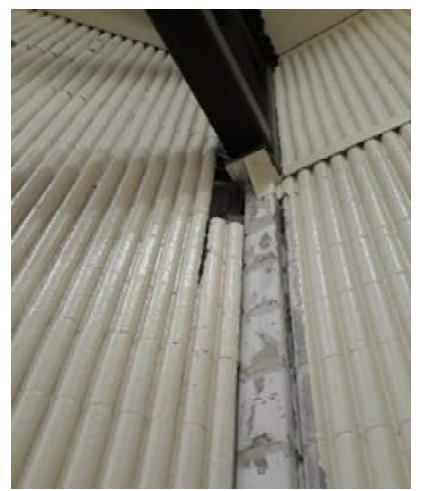
Photo 6-5: CMU Damage at MPR Column

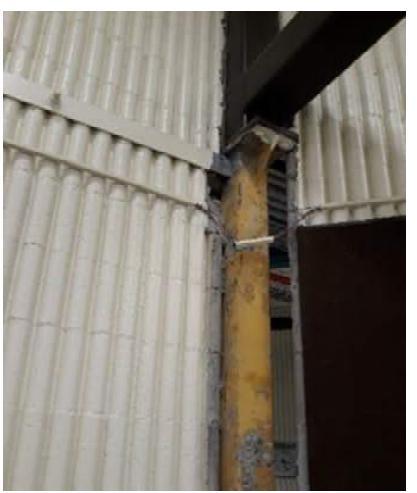
Photo 6-6: CMU Damage at MPR Column

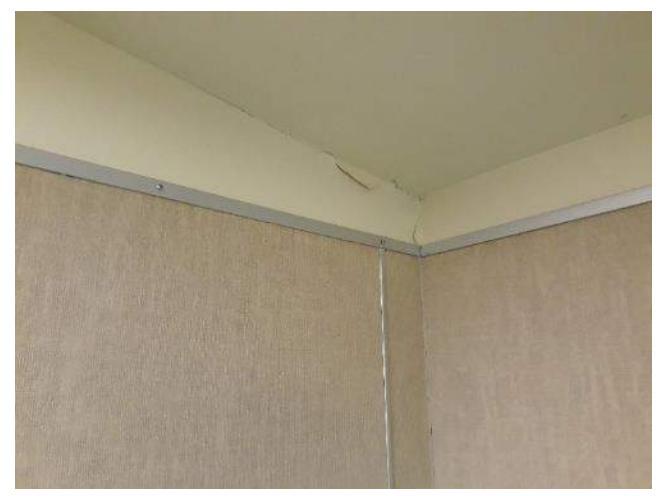
Photo 7-1: Cracked GWB Typical Throughout

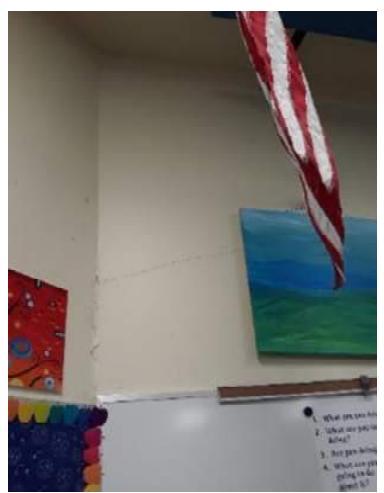
Photo 7-2: Cracked GWB Typical Throughout

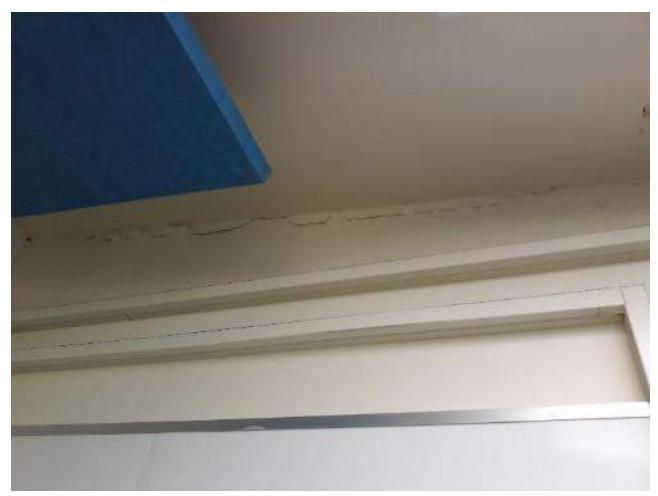
Photo 7-3: Cracked GWB Typical Throughout

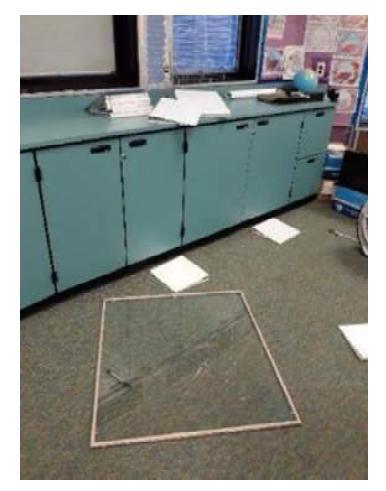
Exterior windows are a part of the original 1984 construction. Windows typically include internal horizontal mini-blinds located inside or a removal storm window style on the building interior side. These windows performed well, and no post-earthquake damages were noticed except 1 interior pane in classroom 204 broke during the earthquake.

Photo 7-4: Broken Window Inner-pane

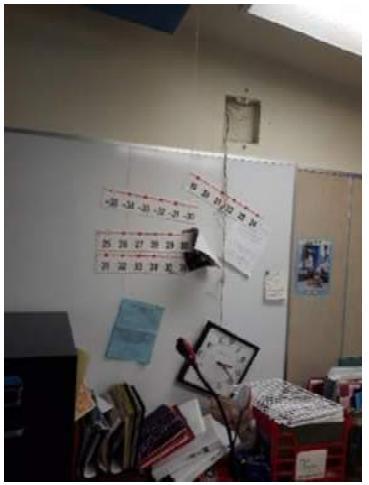
Photo 7-5: Displaced Classroom Clock

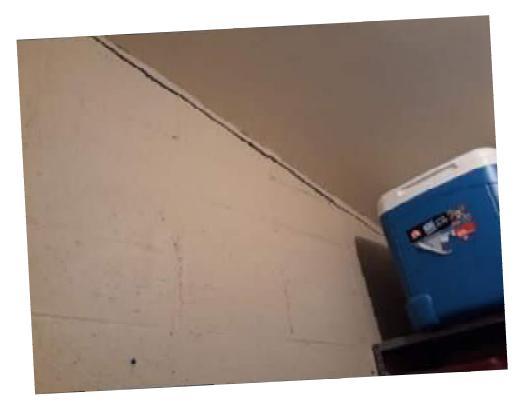
Photo 7-6: CMU Cracking at Top of Wall

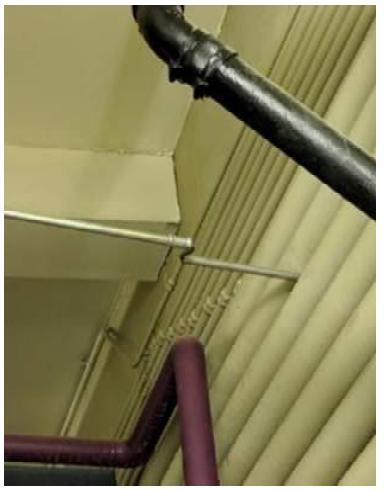
Photo 8-1: Disconnected Conduit

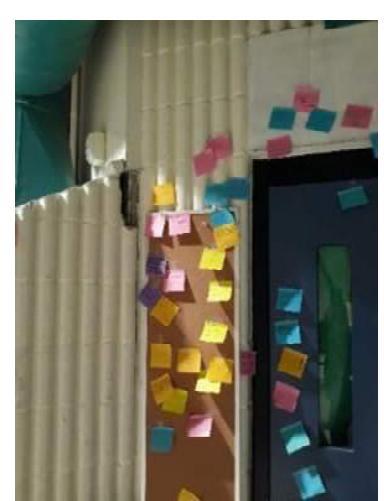
Photo 8-3: Damaged CMU Locker "End Cap"

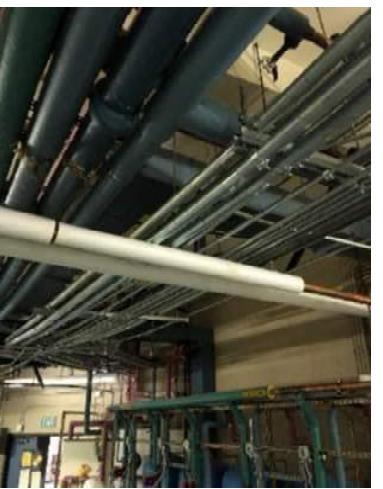
Photo 8-2: Conduit Resting on Piping

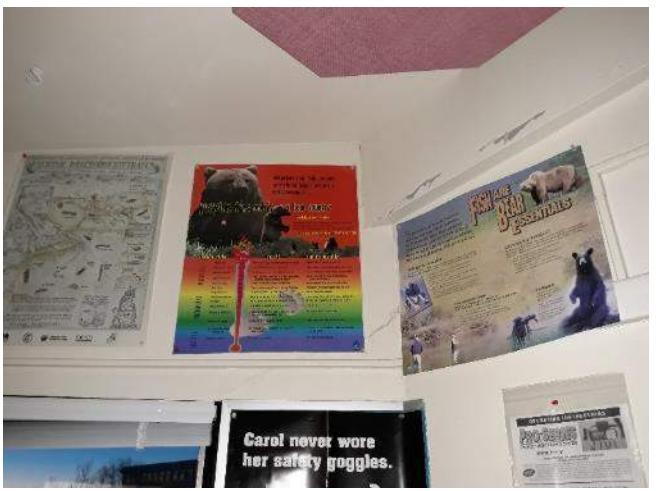
Photo 8-4: Damaged GWB Edge Metal, Typical Throughout

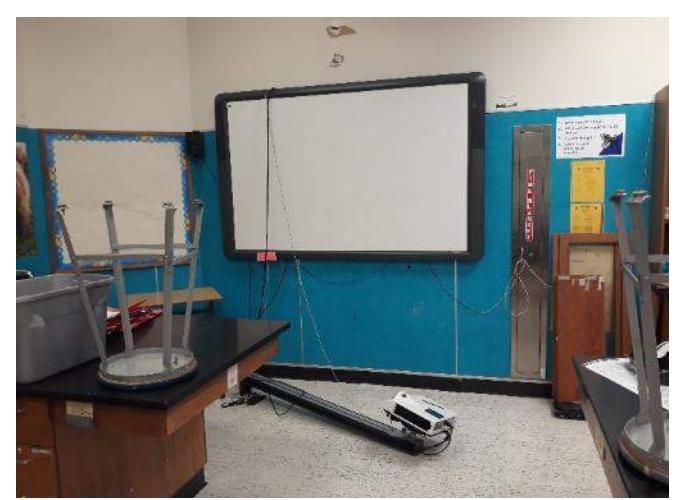
Photo 8-5: Dislodged Computer Projector

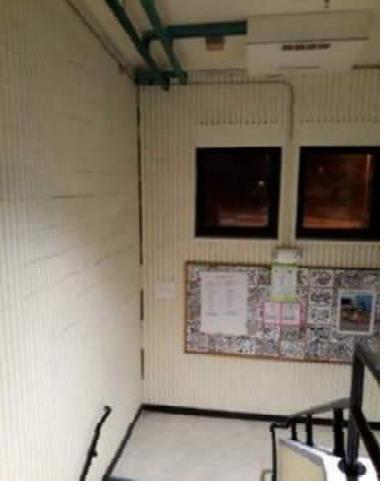
Photo 8-6: Damaged CMU at Stairwell

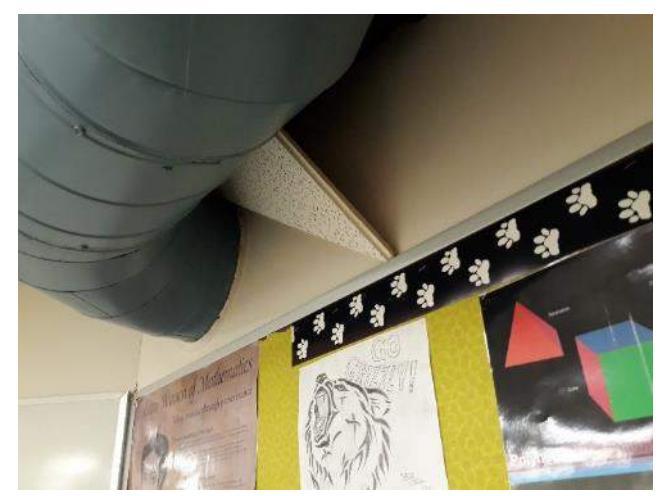
Photo 9-1: Displaced Perimeter Ceiling Tile

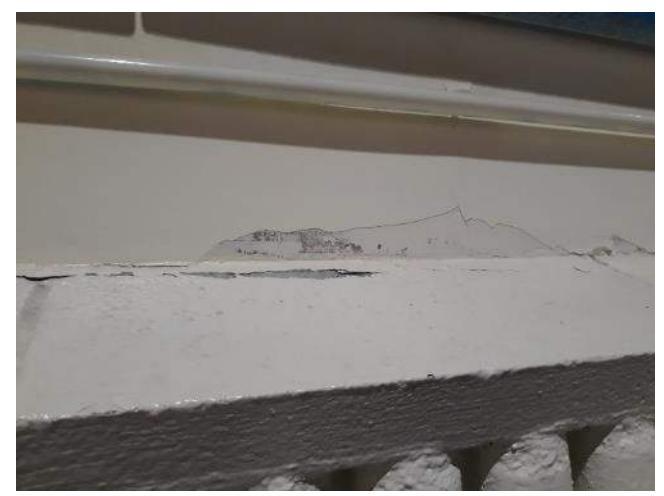
Photo 9-2: Damage at CMU Locker "Cap"

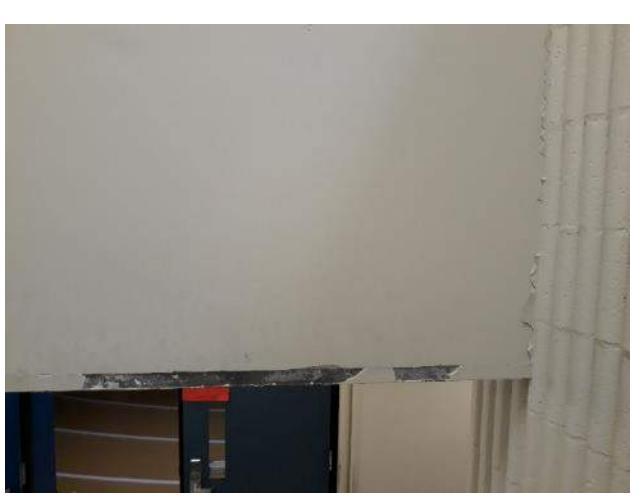
Photo 9-4: Damaged GWB, Typical Throughout

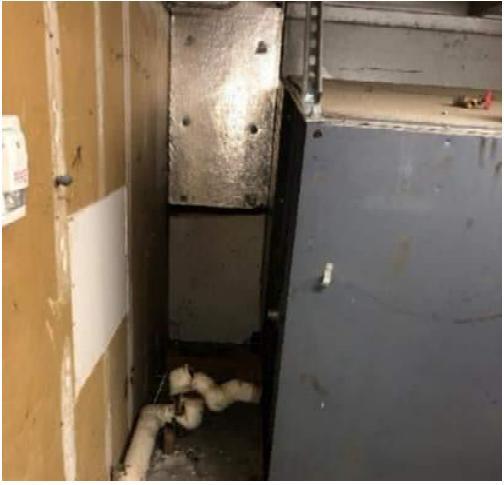
Photo 9-6: Ventilation Unit at Gymnasium

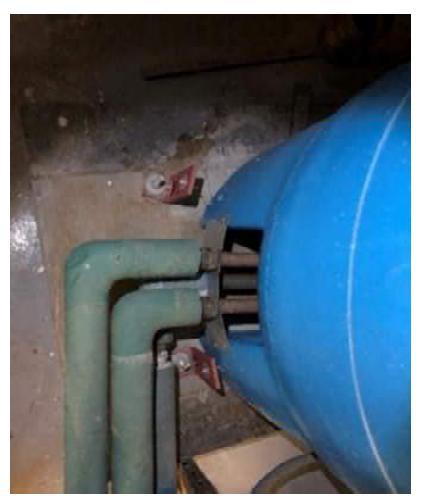
Photo 10-4: Water Heater Securement
