**Geotechnical Engineering Report  
Gruening Middle School Earthquake Repairs  
Eagle River, Alaska**

**GEOTECHNICAL ENGINEERING REPORT  
GRUENING MIDDLE SCHOOL EARTHQUAKE REPAIRS  
EAGLE RIVER, ALASKA**

## **GEOTECHNICAL EVALUATION OF GRUENING MIDDLE SCHOOL FOUNDATION EARTHQUAKE DAMAGE, EAGLE RIVER, ALASKA**

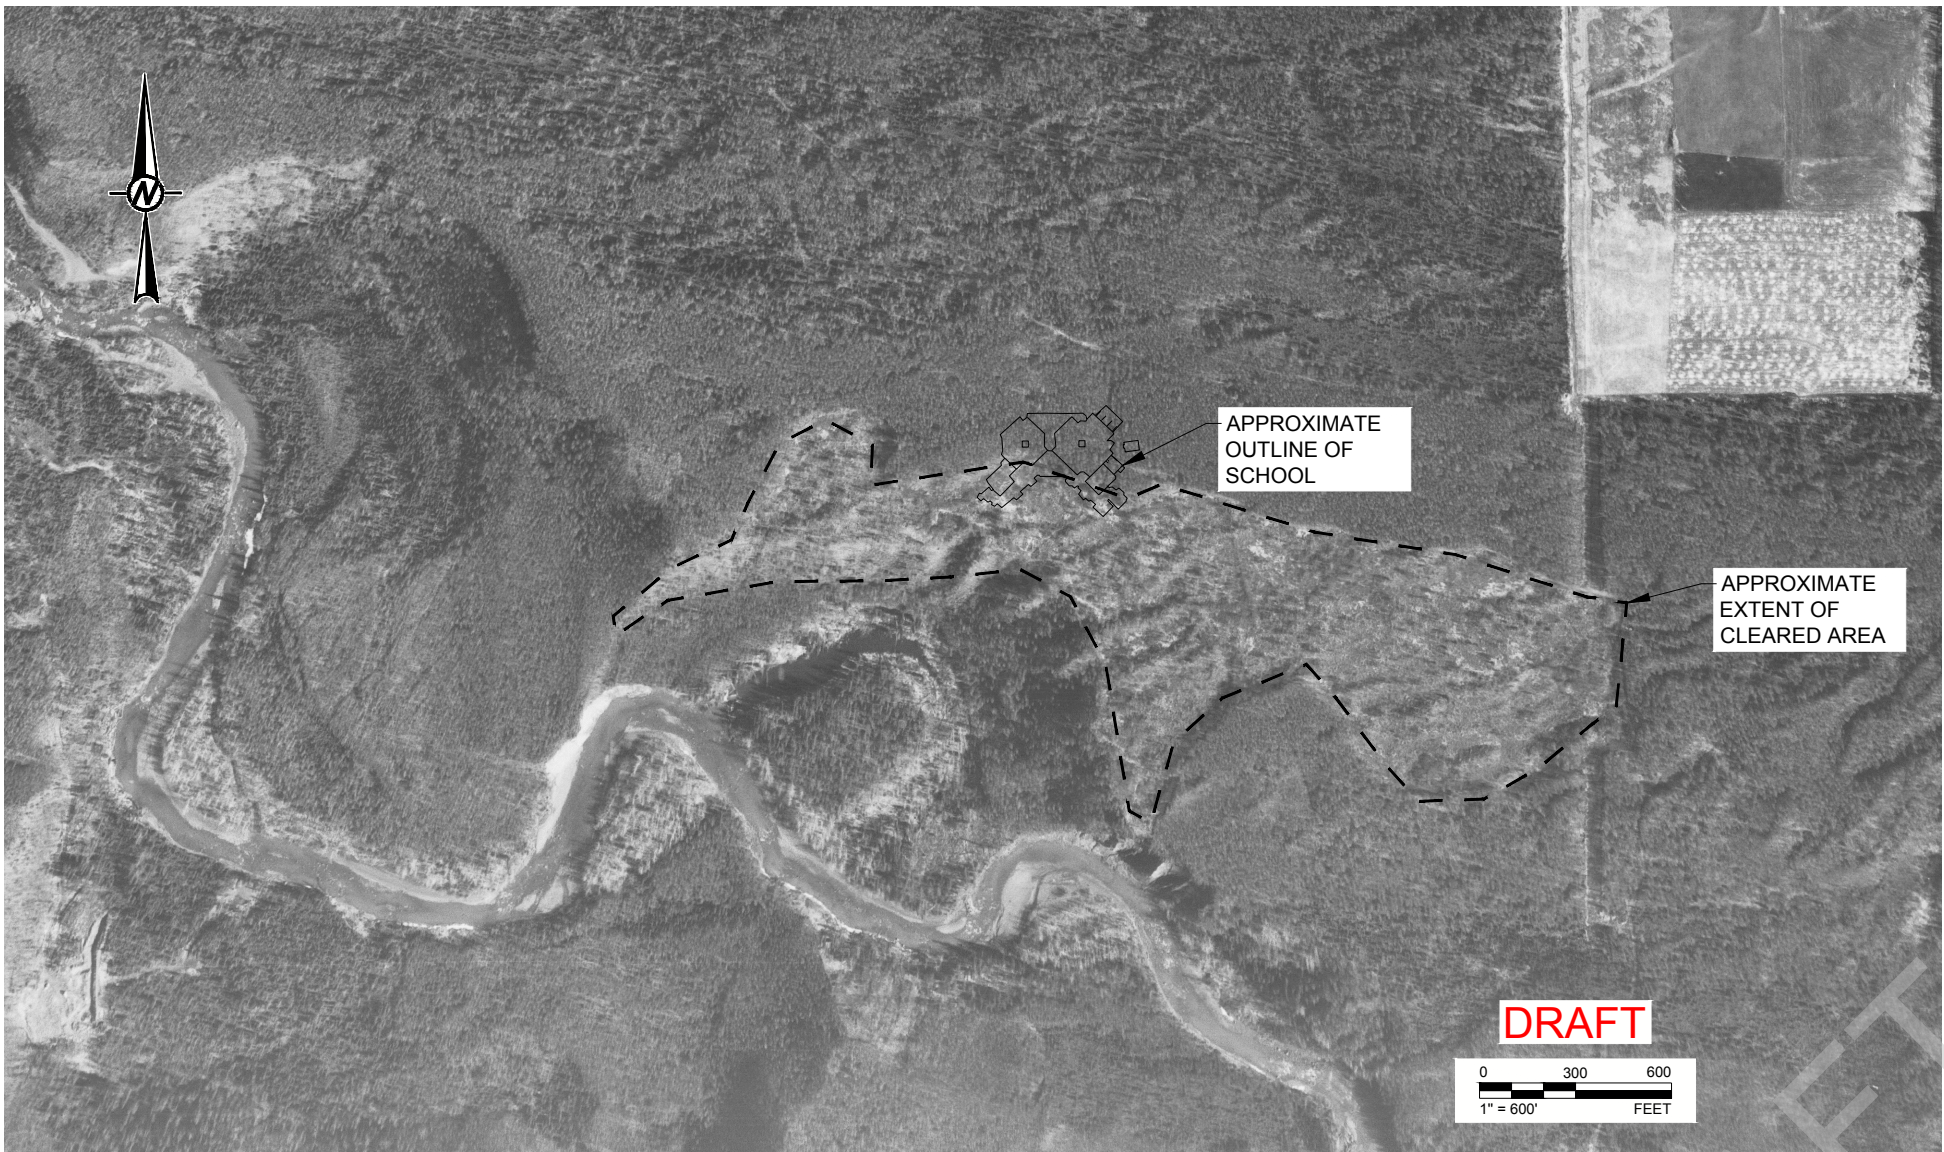
PROJECT NO. 19116560	CONTROL	REV. A	FIGURE 2
-------------------------	---------	-----------	-------------

**REFERENCE(S)**  
AIRPHOTO DATED MAY 31, 1962 WAS OBTAINED FROM THE U.S. GEOLOGICAL SURVEY (USGS) AERIAL PHOTOGRAPHY SINGLE FRAME RECORDS COLLECTION AND DISTRIBUTED BY U.S. GEOLOGICAL SURVEY (USGS) AND EARTH RESOURCES OBSERVATION AND SCIENCE (EROS) CENTER.

A cleared area along the slope leading to Eagle River exists southwest of the school, as seen in Figures 2 through 6. Based on the utility plans, this area has a storm outfall easement that contains a buried 18-inch corrugated steel pipe. The area is also visible on the more recent aerial imagery (Figure 7).

Golder acquired a series of historical aerial images to review the development of the school site and surrounding areas. Specifically, we reviewed aerial images acquired in 1950, 1953, 1957, 1962, 1972, 1977, 1978, 1982, 1984, 1990, 1996, 2002, and 2015. In addition, Golder acquired and reviewed stereo aerial images from 1982, including photos taken on April 30, June 1, June 24, and September 27 of that year, documenting various stages of construction at the school site. Figures 2 through 6 present aerial images of the project site for select years.

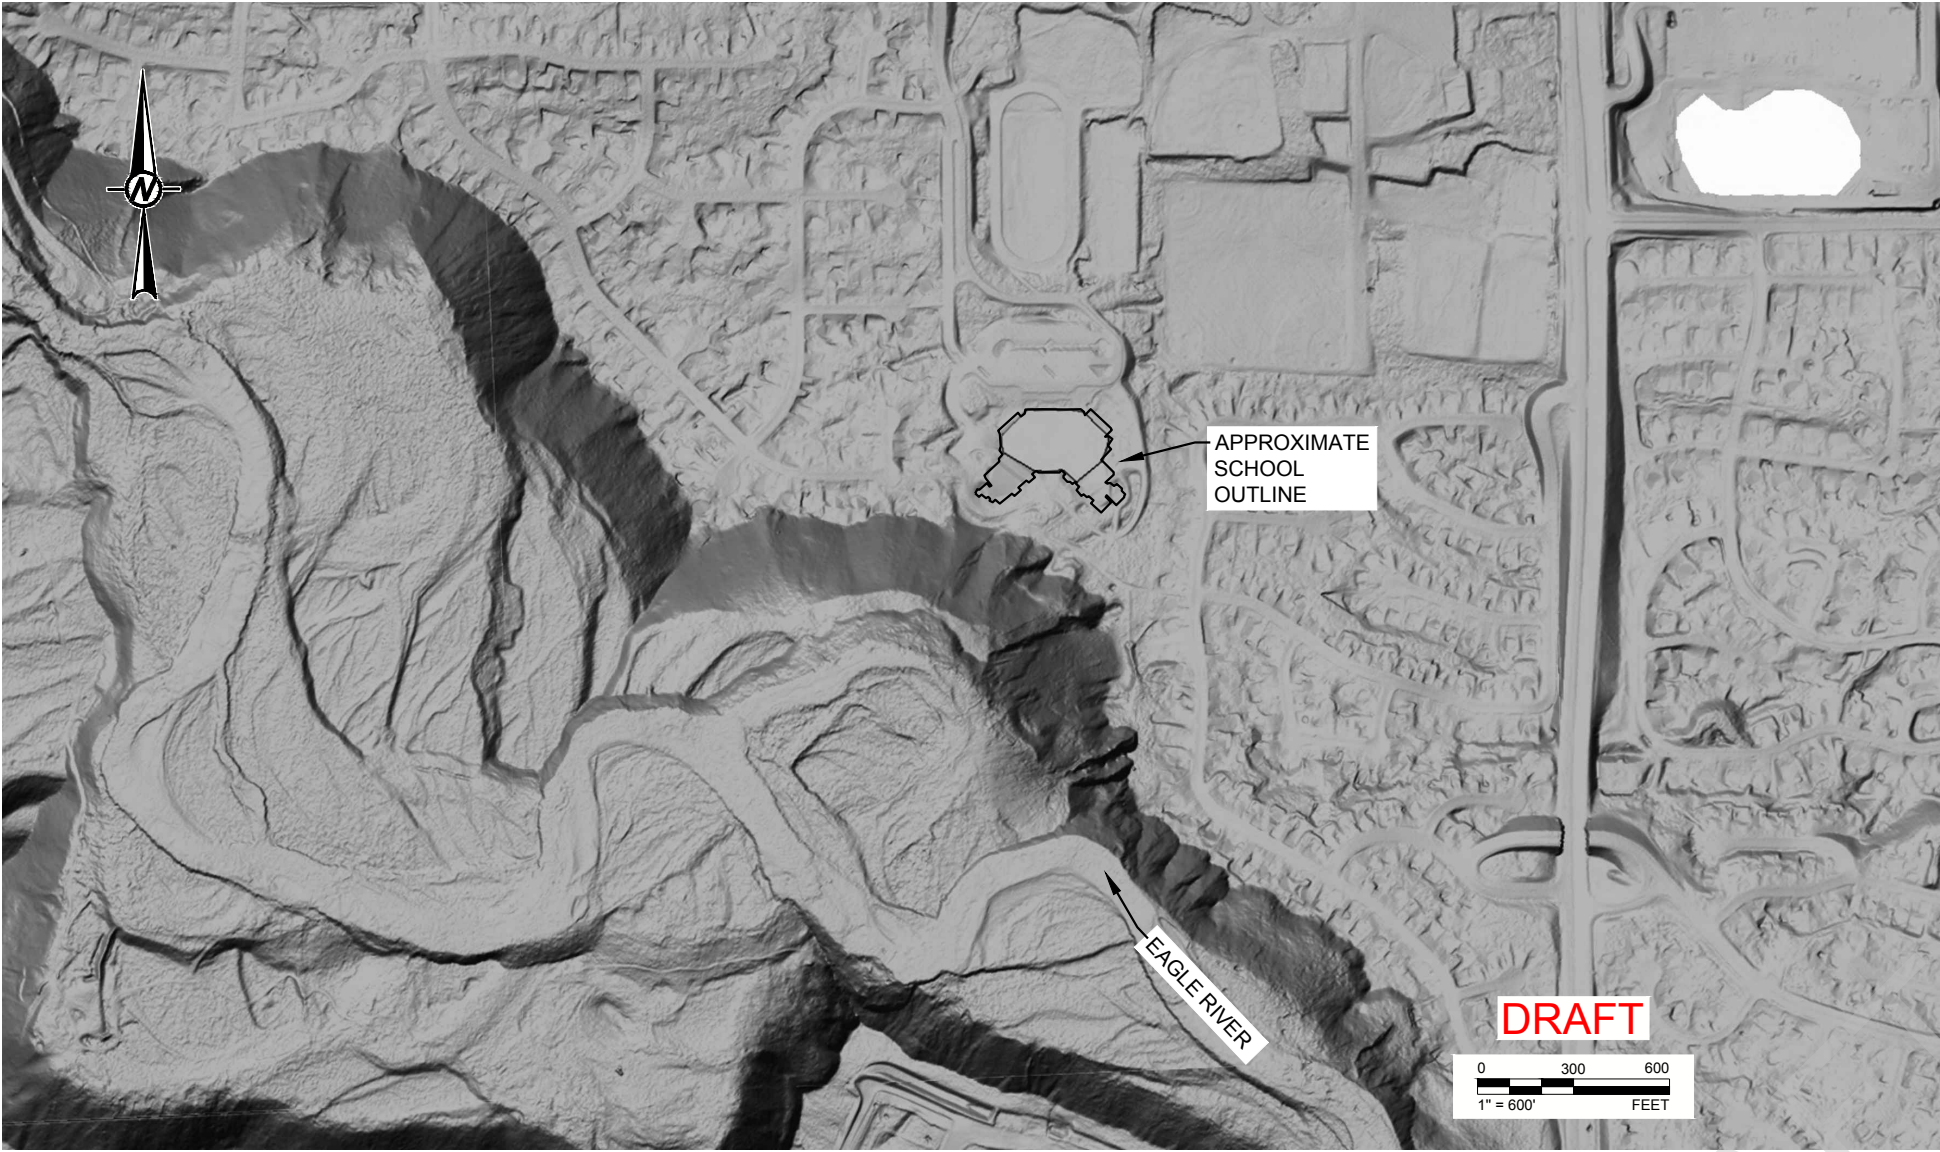
**REFERENCE(S)**  
HILLSHADE IMAGE DEVELOPED FROM GROUND POINT DATA DERIVED FROM LIDAR POINT CLOUD DATA ACQUIRED BY KODIAK MAPPING INC. ON 2018-12-18. LIDAR DATA WAS DISTRIBUTED AS PART OF 2018 EARTHQUAKE-QL2 PHASE 01 DELIVERY AND IS INTENDED TO PROVIDE GENERALIZED SURFACE INFORMATION SUITABLE FOR INITIAL RESPONSE AND ASSESSMENT EFFORTS.

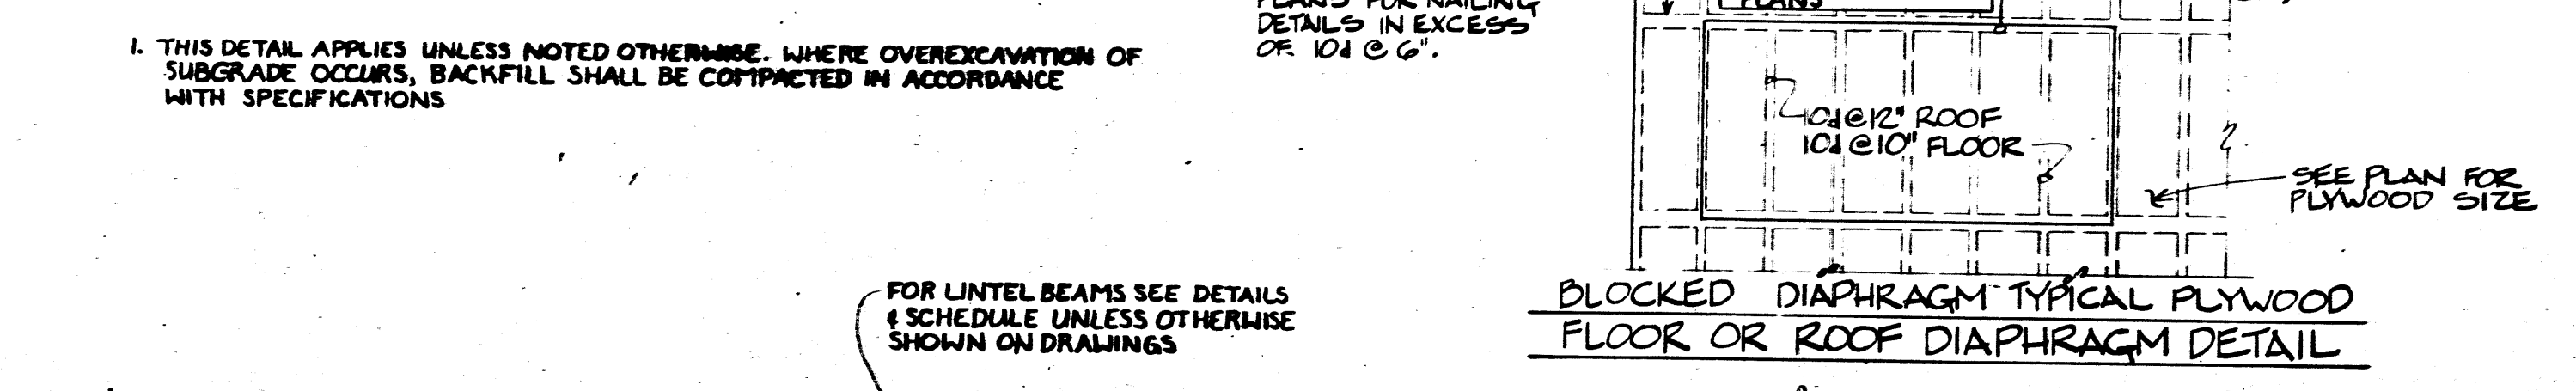
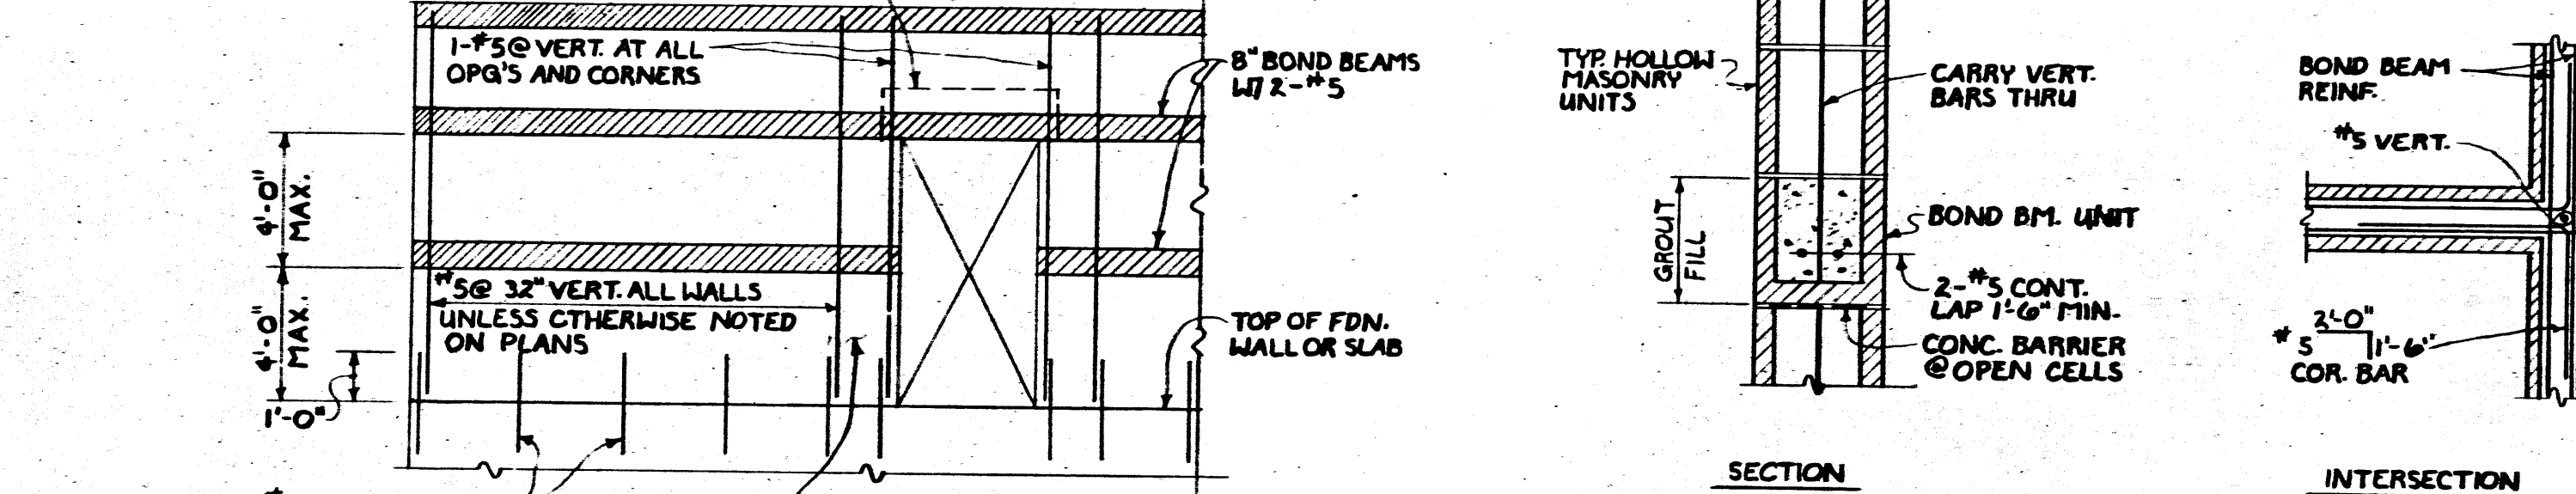
SCALE AS NOTED	DATE DEC 1981
DRAWN PWS	CHECKED PWS
SHEET	S-12
OF 17 SHEETS

FOUNDATION  
SECTIONS &  
DETAILS

- Sheet S-12. Foundation Sections & Details. This sheet shows a number of cross sections for the eastern side of the school, including the gymnasium. Foundation details, including footing size and fill requirements are not presented on this sheet, but are outlined elsewhere in the document, including in the specifications as well as in the geotechnical report discussed in Section 3.2.

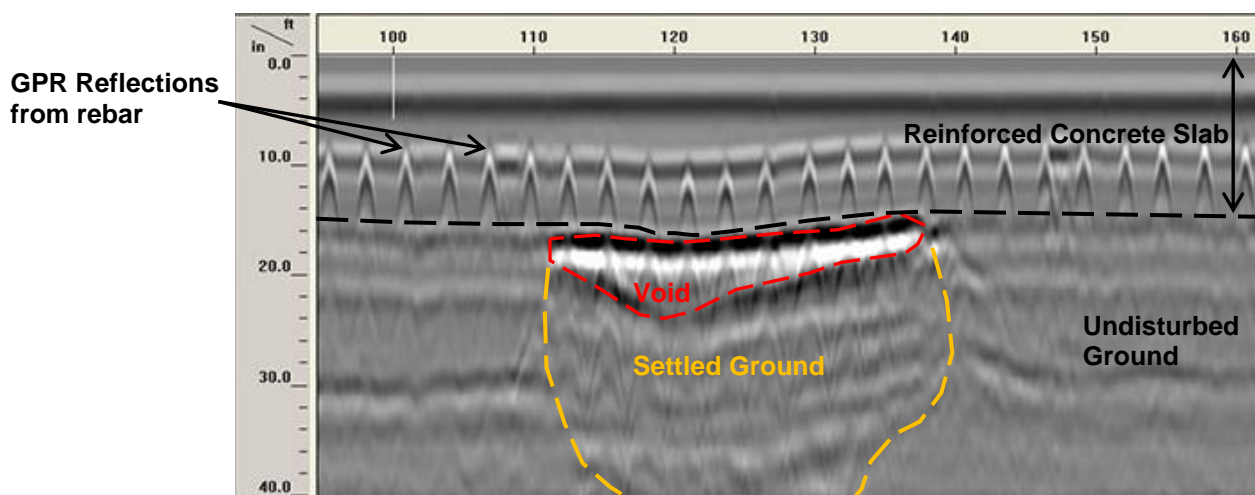
**Example Radargram of a Void and Associated Ground Settlement below a Concrete Slab.**

Based on our geotechnical experience in the area, we understand the shallow subsurface soils largely consist of glacial till, which both allow for acceptable GPR signal penetration and should provide a sharp contrast between the concrete slab and subgrade, as seen in the figure below. We will optimize GPR system settings to be able to image the subsurface below the slab and identify any air-filled gaps or other anomalies between the concrete slab and subgrade. The EMUL may be used to supplement the GPR to identify any buried utilities (particularly power) prior to any drilling activities.

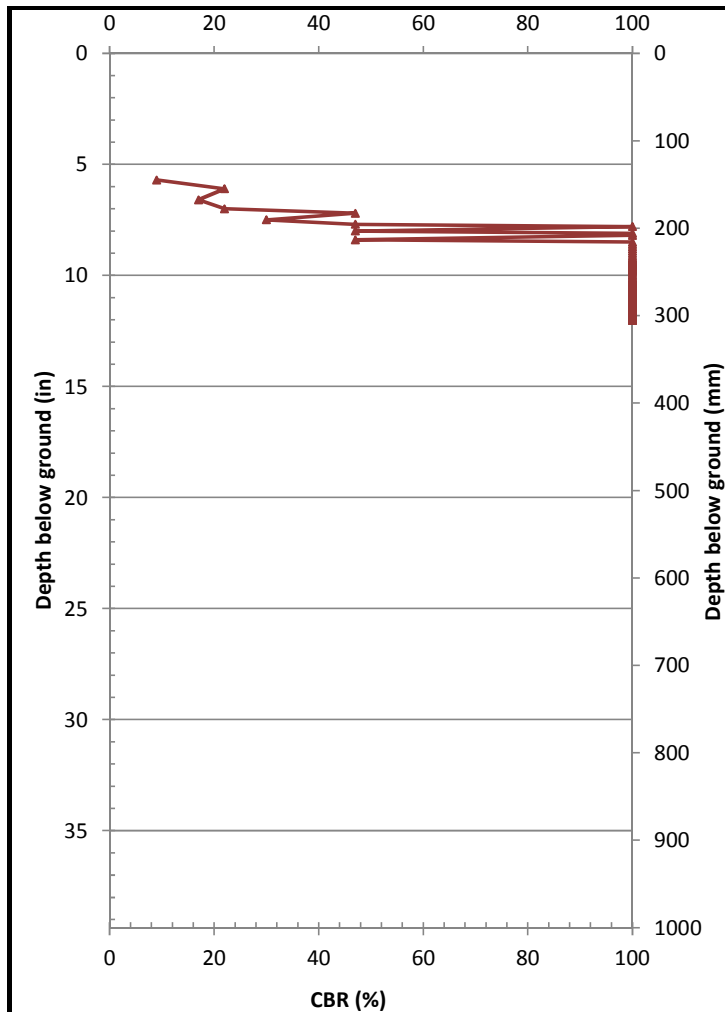
FIG. B-14

Note:  
California Bearing Ratio (CBR) calculated using:  
 $CBR = 292/DPI^{1.12}$   
where DPI = Dynamic Cone Penetration Index (mm/blow)  
as suggested in ASTM D6951/D6951M-09

Blow	Depth (in)	DPI (mm/blow)	CBR	Blow	Depth (in)	DPI (mm/blow)	CBR	Blow	Depth (in)	DPI (mm/blow)	CBR	Number of	Depth (in)	DPI (mm/blow)	CBR
1	5.7	23	9	31	9.6	1	100	61	10.7	1	100	91	11.2	1	100
2	6.1	10	22	32	9.7	1	100	62	10.7	1	100	92	11.3	1	100
3	6.6	13	17	33	9.7	1	100	63	10.8	1	100	93	11.3	1	100
4	7.0	10	22	34	9.8	1	100	64	10.8	1	100	94	11.4	1	100
5	7.2	5	47	35	9.8	1	100	65	10.8	1	100	95	11.4	1	100
6	7.5	8	30	36	9.9	2	100	66	10.8	1	100	96	11.4	1	100
7	7.7	5	47	37	9.9	2	100	67	10.8	1	100	97	11.4	1	100
8	7.8	3	100	38	10.0	2	100	68	10.9	1	100	98	11.5	1	100
9	8.0	5	47	39	10.0	2	100	69	10.9	1	100	99	11.5	1	100
10	8.1	3	100	40	10.1	2	100	70	10.9	1	100	100	11.5	1	100
11	8.2	3	100	41	10.1	1	100	71	10.9	1	100	101	11.5	1	100
12	8.4	5	47	42	10.2	1	100	72	10.9	1	100	102	11.5	1	100
13	8.5	3	100	43	10.2	1	100	73	11.0	1	100	103	11.6	1	100
14	8.6	3	100	44	10.3	1	100	74	11.0	1	100	104	11.6	1	100
15	8.7	3	100	45	10.3	1	100	75	11.0	1	100	105	11.6	1	100

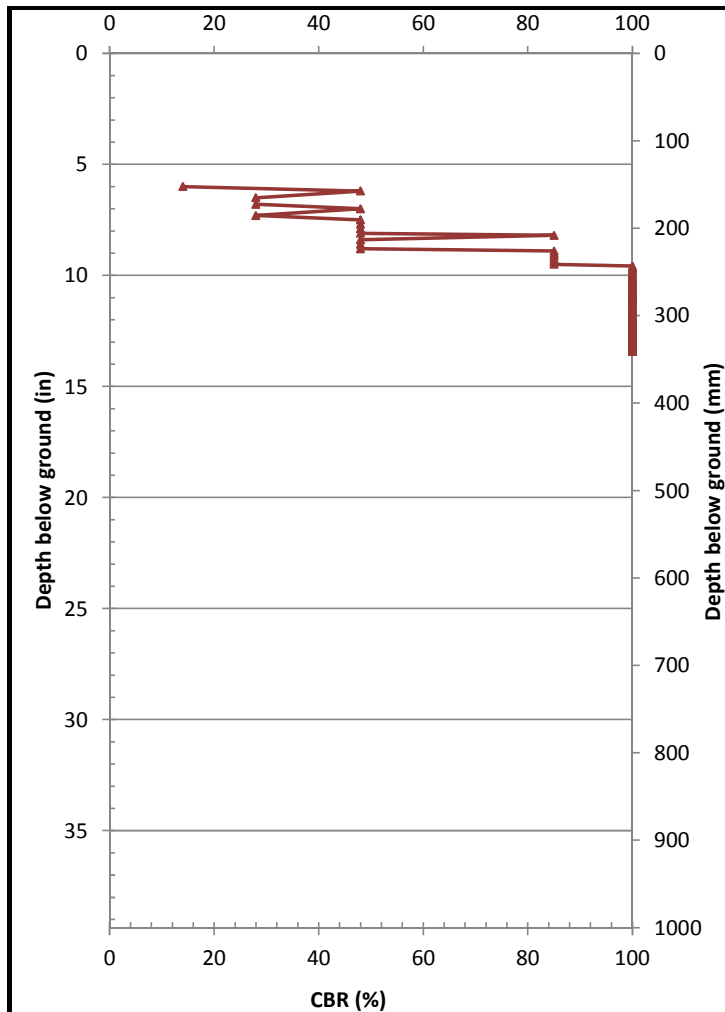
**FIG. B-15**  
Sheet 2 of 2

— B-08 CBR Values

Note:  
California Bearing Ratio (CBR) calculated using:  
 $CBR = 292/DPI^{1.12}$   
where DPI = Dynamic Cone Penetration Index (mm/blow)  
as suggested in ASTM D6951/D6951M-09

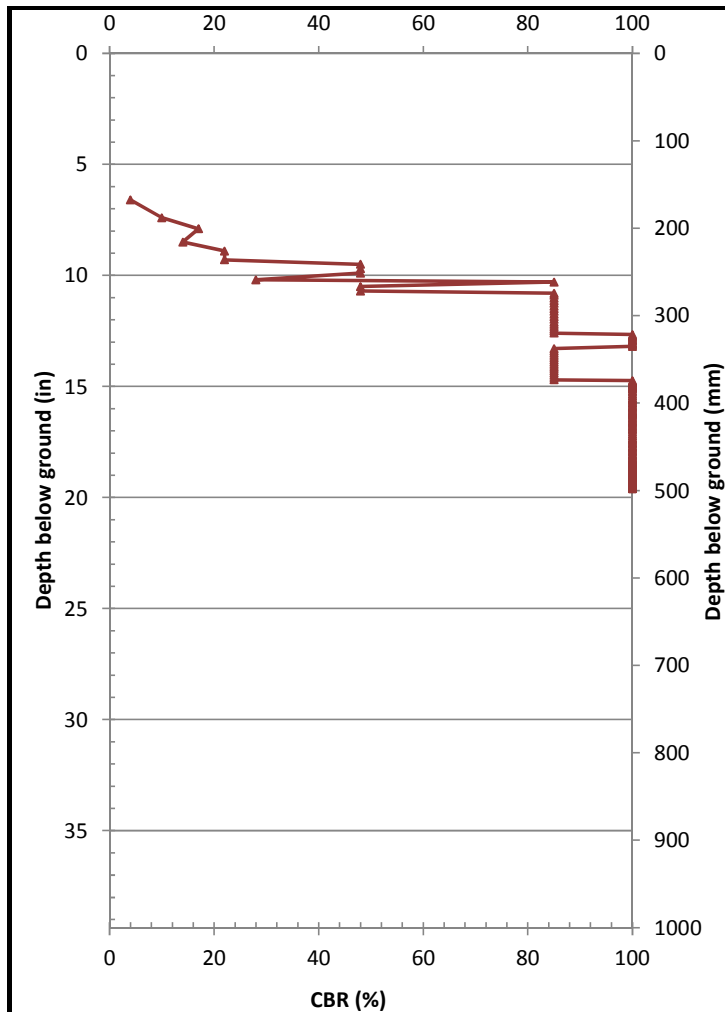
**FIG. B-16**  
Sheet 2 of 2

Blow	Depth (in)	DPI (mm/blow)	CBR	Blow	Depth (in)	DPI (mm/blow)	CBR	Blow	Depth (in)	DPI (mm/blow)	CBR	Number of	Depth (in)	DPI (mm/blow)	CBR
1	6.6	46	4	31	12.7	2	100	61	14.9	1	100	91	16.7	2	100
2	7.4	20	10	32	12.7	2	100	62	15.0	1	100	92	16.7	2	100
3	7.9	13	17	33	12.8	2	100	63	15.0	1	100	93	16.8	2	100
4	8.5	15	14	34	12.8	2	100	64	15.1	1	100	94	16.8	2	100
5	8.9	10	22	35	12.9	2	100	65	15.1	1	100	95	16.9	2	100
6	9.3	10	22	36	13.0	2	100	66	15.2	2	100	96	17.0	2	100
7	9.5	5	48	37	13.0	2	100	67	15.3	2	100	97	17.1	2	100
8	9.7	5	48	38	13.1	2	100	68	15.3	2	100	98	17.1	2	100
9	9.9	5	48	39	13.1	2	100	69	15.4	2	100	99	17.2	2	100
10	10.2	8	28	40	13.2	2	100	70	15.5	2	100	100	17.3	2	100
11	10.3	3	85	41	13.3	3	85	71	15.6	2	100	101	17.4	2	100
12	10.5	5	48	42	13.4	3	85	72	15.6	2	100	102	17.4	2	100
13	10.7	5	48	43	13.5	3	85	73	15.7	2	100	103	17.5	2	100
14	10.8	3	85	44	13.6	3	85	74	15.7	2	100	104	17.5	2	100
15	10.9	3	85	45	13.7	3	85	75	15.8	2	100	105	17.6	2	100

16	11.0	3	85	46	13.8	3	85	76	15.9	2	100	106	17.7	2	100
17	11.1	3	85	47	13.9	3	85	77	15.9	2	100	107	17.7	2	100
18	11.3	3	85	48	14.0	3	85	78	16.0	2	100	108	17.8	2	100
19	11.4	3	85	49	14.1	3	85	79	16.0	2	100	109	17.8	2	100
20	11.5	3	85	50	14.2	3	85	80	16.1	2	100	110	17.9	2	100
21	11.6	3	85	51	14.3	3	85	81	16.1	1	100	111	18.0	2	100
22	11.7	3	85	52	14.4	3	85	82	16.2	1	100	112	18.0	2	100
23	11.9	3	85	53	14.5	3	85	83	16.2	1	100	113	18.1	2	100
24	12.0	3	85	54	14.6	3	85	84	16.3	1	100	114	18.1	2	100
25	12.1	3	85	55	14.7	3	85	85	16.3	1	100	115	18.2	2	100
26	12.2	3	85	56	14.7	1	100	86	16.4	2	100	116	18.2	1	100
27	12.3	3	85	57	14.8	1	100	87	16.4	2	100	117	18.3	1	100
28	12.4	3	85	58	14.8	1	100	88	16.5	2	100	118	18.3	1	100
29	12.5	3	85	59	14.9	1	100	89	16.5	2	100	119	18.4	1	100
30	12.6	3	85	60	14.9	1	100	90	16.6	2	100	120	18.4	1	100

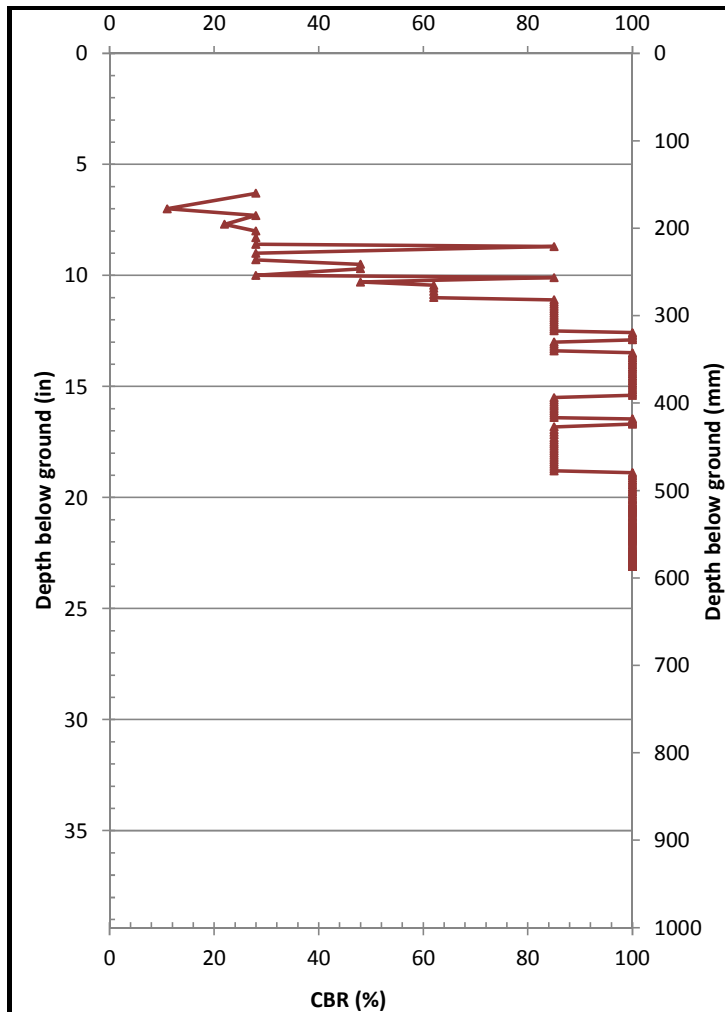
**FIG. B-17**  
Sheet 2 of 2

Blow	Depth (in)	DPI (mm/blow)	CBR	Blow	Depth (in)	DPI (mm/blow)	CBR	Blow	Depth (in)	DPI (mm/blow)	CBR	Num ber of	Depth (in)	DPI (mm/blow)	CBR
1	6.3	8	28	31	12.1	3	85	61	14.7	2	100	91	17.4	3	85
2	7.0	18	11	32	12.2	3	85	62	14.8	2	100	92	17.5	3	85
3	7.3	8	28	33	12.3	3	85	63	14.8	2	100	93	17.6	3	85
4	7.7	10	22	34	12.4	3	85	64	14.9	2	100	94	17.7	3	85
5	8.0	8	28	35	12.5	3	85	65	15.0	2	100	95	17.8	3	85
6	8.3	8	28	36	12.6	2	100	66	15.1	2	100	96	17.9	3	85
7	8.6	8	28	37	12.7	2	100	67	15.2	2	100	97	18.0	3	85
8	8.7	3	85	38	12.7	2	100	68	15.2	2	100	98	18.1	3	85
9	9.0	8	28	39	12.8	2	100	69	15.3	2	100	99	18.2	3	85
10	9.3	8	28	40	12.9	2	100	70	15.4	2	100	100	18.3	3	85
11	9.5	5	48	41	13.0	3	85	71	15.5	3	85	101	18.4	3	85
12	9.7	5	48	42	13.1	3	85	72	15.6	3	85	102	18.5	3	85
13	10.0	8	28	43	13.2	3	85	73	15.7	3	85	103	18.6	3	85
14	10.1	3	85	44	13.3	3	85	74	15.8	3	85	104	18.7	3	85
15	10.3	5	48	45	13.4	3	85	75	15.9	3	85	105	18.8	3	85

16	10.4	4	62	46	13.5	2	100	76	16.0	3	85	106	18.9	2	100
17	10.6	4	62	47	13.6	2	100	77	16.1	3	85	107	19.0	2	100
18	10.7	4	62	48	13.6	2	100	78	16.2	3	85	108	19.0	2	100
19	10.9	4	62	49	13.7	2	100	79	16.3	3	85	109	19.1	2	100
20	11.0	4	62.0	50	13.8	2	100	80	16.4	3	85	110	19.2	2	100
21	11.1	3	85	51	13.9	2	100	81	16.5	2	100	111	19.3	2	100
22	11.2	3	85	52	14.0	2	100	82	16.5	2	100	112	19.4	2	100
23	11.3	3	85	53	14.0	2	100	83	16.6	2	100	113	19.4	2	100
24	11.4	3	85	54	14.1	2	100	84	16.6	2	100	114	19.5	2	100
25	11.5	3	85	55	14.2	2	100	85	16.7	2	100	115	19.6	2	100
26	11.6	3	85	56	14.3	2	100	86	16.8	3	85	116	19.7	2	100
27	11.7	3	85	57	14.4	2	100	87	16.9	3	85	117	19.8	2	100
28	11.8	3	85	58	14.4	2	100	88	17.1	3	85	118	19.8	2	100
29	11.9	3	85	59	14.5	2	100	89	17.2	3	85	119	19.9	2	100
30	12.0	3	85	60	14.6	2	100	90	17.3	3	85	120	20.0	2	100

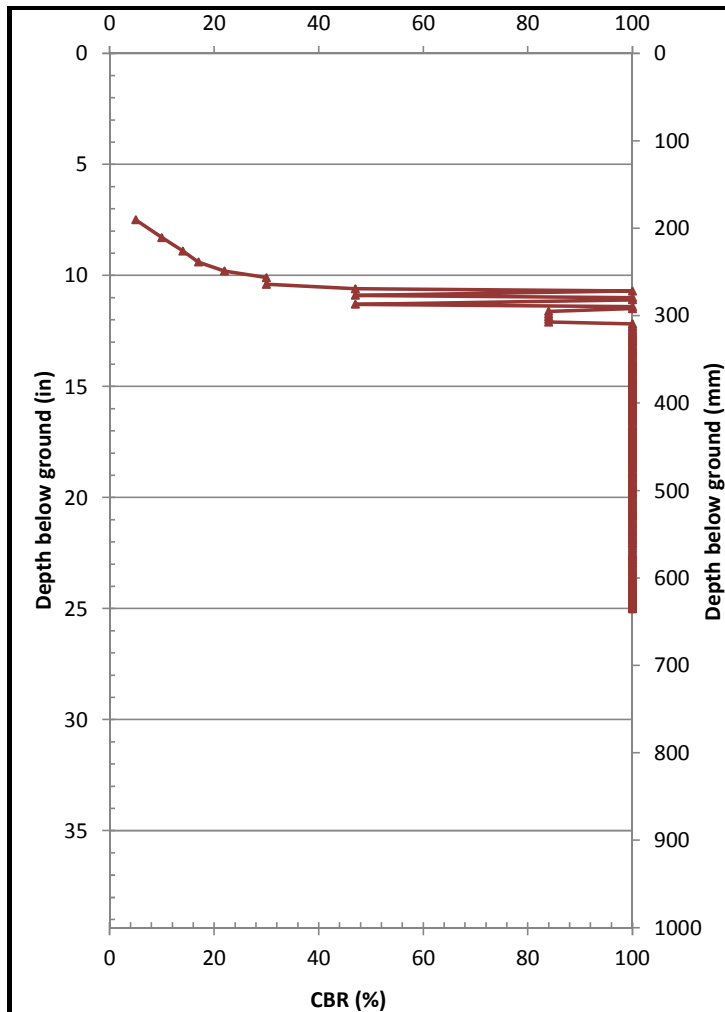
**FIG. B-18**  
Sheet 2 of 2

Blow	Depth (in)	DPI (mm/blow)	CBR	Blow	Depth (in)	DPI (mm/blow)	CBR	Blow	Depth (in)	DPI (mm/blow)	CBR	Number of	Depth (in)	DPI (mm/blow)	CBR
1	7.5	38	5	31	12.8	1	100	61	14.1	1	100	91	15.1	1	100
2	8.3	20	10	32	12.9	1	100	62	14.2	1	100	92	15.2	1	100
3	8.9	15	14	33	12.9	1	100	63	14.2	1	100	93	15.2	1	100
4	9.4	13	17	34	13.0	1	100	64	14.3	1	100	94	15.3	1	100
5	9.8	10	22	35	13.0	1	100	65	14.3	1	100	95	15.3	1	100
6	10.1	8	30	36	13.1	2	100	66	14.3	0	100	96	15.3	1	100
7	10.4	8	30	37	13.1	2	100	67	14.3	0	100	97	15.4	1	100
8	10.6	5	47	38	13.2	2	100	68	14.3	0	100	98	15.4	1	100
9	10.7	3	100	39	13.2	2	100	69	14.3	0	100	99	15.5	1	100
10	10.9	5	47	40	13.3	2	100	70	14.3	0	100	100	15.5	1	100
11	11.0	3	100	41	13.3	1	100	71	14.4	2	100	101	15.5	1	100
12	11.1	3	100	42	13.4	1	100	72	14.4	2	100	102	15.5	1	100
13	11.3	5	47	43	13.4	1	100	73	14.5	2	100	103	15.6	1	100
14	11.4	3	100	44	13.5	1	100	74	14.5	2	100	104	15.6	1	100
15	11.5	3	100	45	13.5	1	100	75	14.6	2	100	105	15.6	1	100

16	11.6	3	84	46	13.6	2	100	76	14.6	1	100	106	15.6	1	100
17	11.7	3	84	47	13.6	2	100	77	14.6	1	100	107	15.7	1	100
18	11.9	3	84	48	13.7	2	100	78	14.7	1	100	108	15.7	1	100
19	12.0	3	84	49	13.7	2	100	79	14.7	1	100	109	15.8	1	100
20	12.1	3	84	50	13.8	2	100	80	14.7	1	100	110	15.8	1	100
21	12.2	2	100	51	13.8	1	100	81	14.7	1	100	111	15.8	1	100
22	12.3	2	100	52	13.8	1	100	82	14.8	1	100	112	15.8	1	100
23	12.3	2	100	53	13.9	1	100	83	14.8	1	100	113	15.9	1	100
24	12.4	2	100	54	13.9	1	100	84	14.9	1	100	114	15.9	1	100
25	12.5	2	100	55	13.9	1	100	85	14.9	1	100	115	15.9	1	100
26	12.6	2	100	56	13.9	1	100	86	14.9	1	100	116	15.9	1	100
27	12.6	2	100	57	14.0	1	100	87	15.0	1	100	117	16.0	1	100
28	12.7	2	100	58	14.0	1	100	88	15.0	1	100	118	16.0	1	100
29	12.7	2	100	59	14.1	1	100	89	15.1	1	100	119	16.1	1	100
30	12.8	2	100	60	14.1	1	100	90	15.1	1	100	120	16.1	1	100

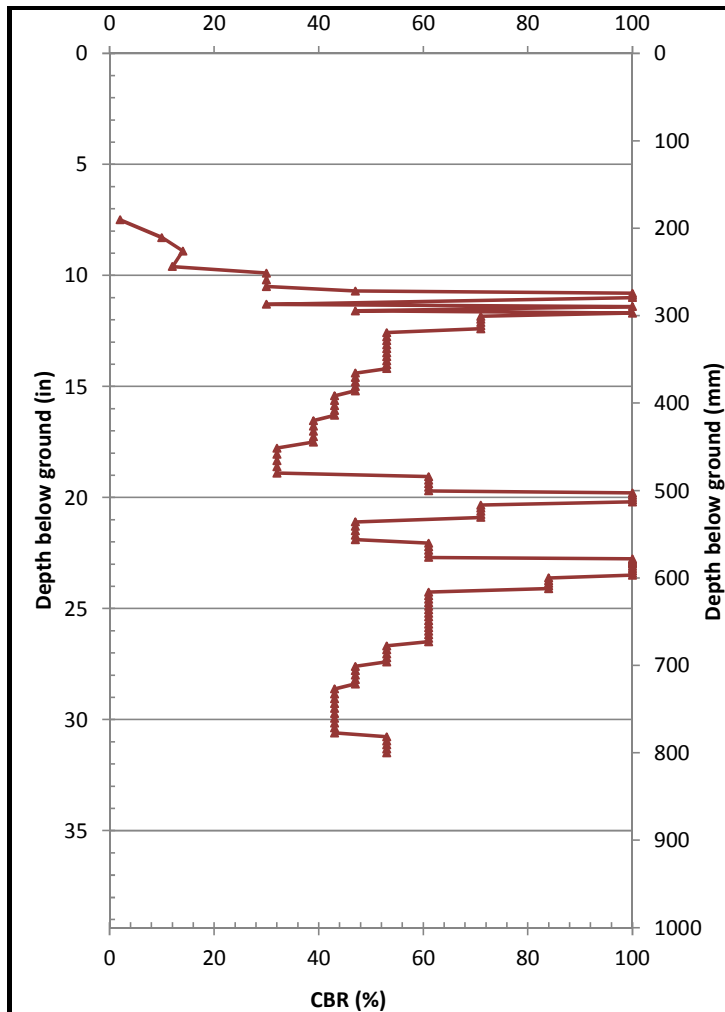
**FIG. B-19**  
Sheet 3 of 3

— TH-2 CBR Values

Note:  
California Bearing Ratio (CBR) calculated using:  
 $CBR = 292/DPI^{1.12}$   
where DPI = Dynamic Cone Penetration Index (mm/blow)  
as suggested in ASTM D6951/D6951M-09

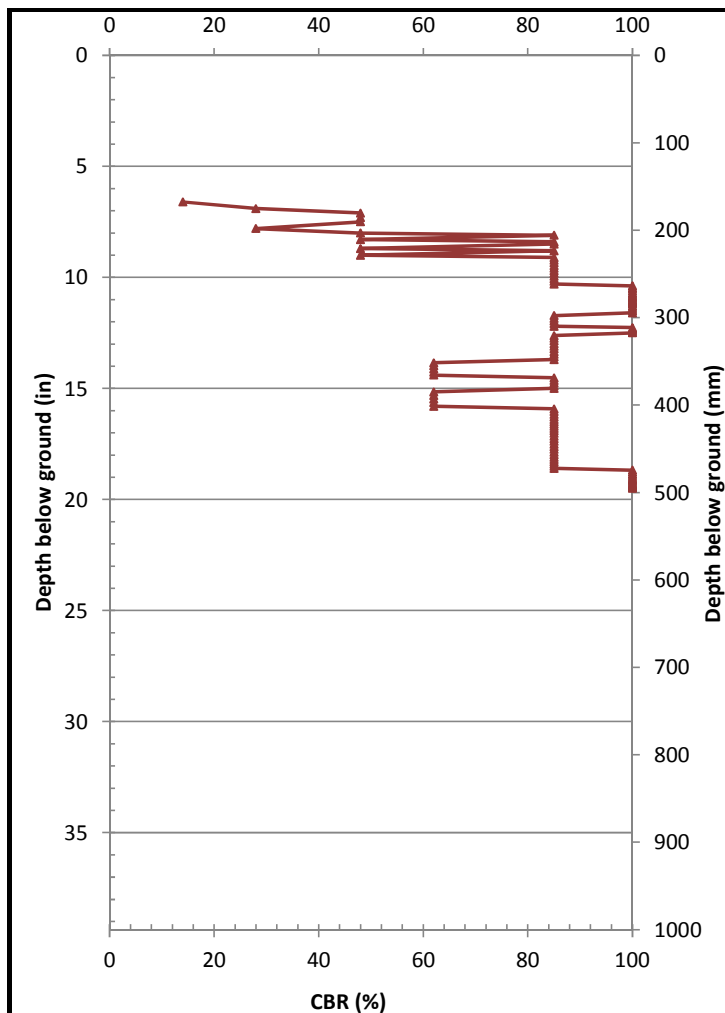
**FIG. B-20**  
Sheet 2 of 2

Blow	Depth (in)	DPI (mm/blow)	CBR	Blow	Depth (in)	DPI (mm/blow)	CBR	Blow	Depth (in)	DPI (mm/blow)	CBR	Blow	Depth (in)	DPI (mm/blow)	CBR
1	6.6	15	14	31	10.8	2	100	61	13.2	3	85	91	17.0	3	85
2	6.9	8	28	32	10.8	2	100	62	13.3	3.0	85	92	17.1	3	85
3	7.1	5	48	33	10.9	2	100	63	13.5	3.0	85	93	17.3	3	85
4	7.3	5	48	34	10.9	2	100	64	13.6	3.0	85	94	17.4	3	85
5	7.5	5	48	35	11.0	2	100	65	13.7	3.0	85	95	17.5	3	85
6	7.8	8	28	36	11.0	1	100	66	13.8	4.0	62	96	17.6	3	85
7	8.0	5	48	37	11.1	1	100	67	14.0	4	62	97	17.7	3	85
8	8.1	3	85	38	11.1	1	100	68	14.1	4	62	98	17.9	3	85
9	8.3	5	48	39	11.2	1	100	69	14.3	4	62	99	18.0	3	85
10	8.4	3	85	40	11.2	1	100	70	14.4	4	62	100	18.1	3	85
11	8.5	3	85	41	11.3	2	100	71	14.5	3	85	101	18.2	3	85
12	8.7	5	48	42	11.4	2	100	72	14.6	3	85	102	18.3	3	85
13	8.8	3	85	43	11.4	2	100	73	14.8	3	85	103	18.4	3	85
14	9.0	5	48	44	11.5	2	100	74	14.9	3	85	104	18.5	3	85
15	9.1	3	85	45	11.6	2	100	75	15.0	3	85	105	18.6	3	85

16	9.2	3	85	46	11.7	3	85	76	15.2	4	62	106	18.7	2	100
17	9.3	3	85	47	11.8	3	85	77	15.3	4	62	107	18.8	2	100
18	9.5	3	85	48	12	3	85	78	15.5	4	62	108	18.8	2	100
19	9.6	3	85	49	12.1	3	85	79	15.6	4	62	109	18.9	2	100
20	9.7	3	85.0	50	12.2	3	85	80	15.8	4	62	110	19.0	2	100
21	9.8	3	85	51	12.3	2	100	81	15.9	3	85	111	19.1	2	100
22	9.9	3	85	52	12.3	2	100	82	16.0	3	85	112	19.1	2	100
23	10.1	3	85	53	12.4	2	100	83	16.2	3	85	113	19.2	2	100
24	10.2	3	85	54	12.4	2	100	84	16.3	3	85	114	19.2	2	100
25	10.3	3	85	55	12.5	2	100	85	16.4	3	85	115	19.3	2	100
26	10.4	2	100	56	12.6	3	85	86	16.5	3	85	116	19.3	1	100
27	10.5	2	100	57	12.7	3	85	87	16.6	3	85	117	19.4	1	100
28	10.5	2	100	58	12.9	3	85	88	16.7	3	85	118	19.4	1	100
29	10.6	2	100	59	13	3	85	89	16.8	3	85	119	19.5	1	100
30	10.7	2	100	60	13.1	3	85	90	16.9	3	85	120	19.5	1	100

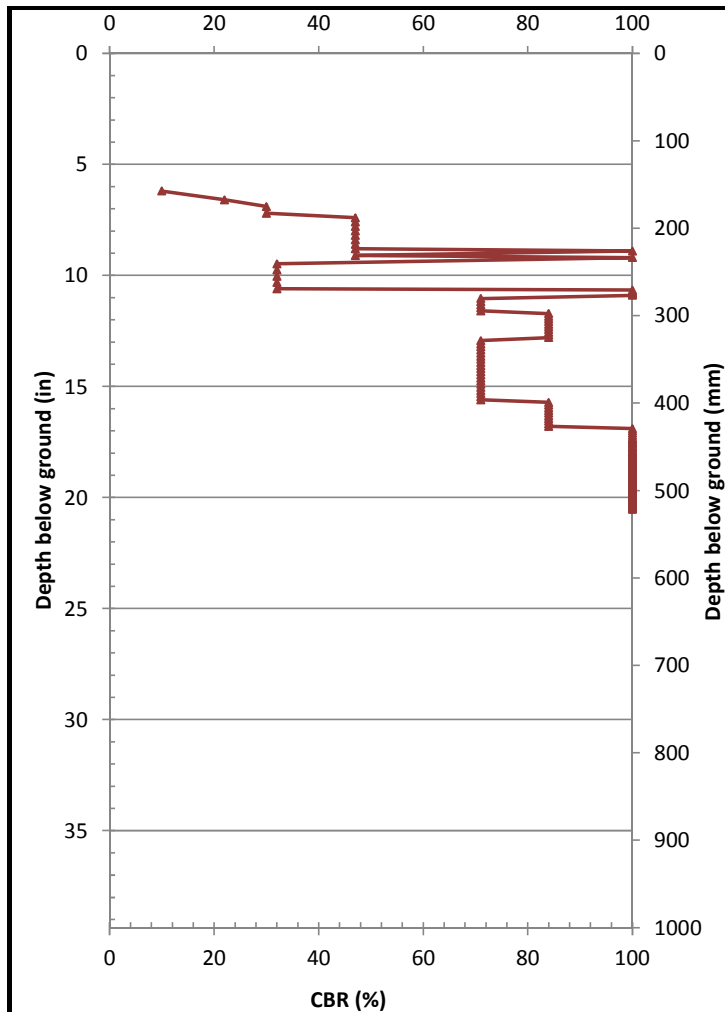
FIG. B-21

Blow	Depth (in)	DPI (mm/blow)	CBR	Blow	Depth (in)	DPI (mm/blow)	CBR	Blow	Depth (in)	DPI (mm/blow)	CBR	Num ber of	Depth (in)	DPI (mm/blow)	CBR
1	6.2	20	10	31	11.7	3	84	61	15.7	3	84	91	18.1	1	100
2	6.6	10	22	32	11.8	3	84	62	15.8	3	84	92	18.2	1	100
3	6.9	8	30	33	12.0	3	84	63	16.0	3	84	93	18.2	1	100
4	7.2	8	30	34	12.1	3	84	64	16.1	3	84	94	18.3	1	100
5	7.4	5	47	35	12.2	3	84	65	16.2	3	84	95	18.3	1	100
6	7.6	5	47	36	12.3	3	84	66	16.3	3	84	96	18.3	1	100
7	7.8	5	47	37	12.4	3	84	67	16.4	3	84	97	18.3	1	100
8	8.0	5	47	38	12.6	3	84	68	16.6	3	84	98	18.4	1	100
9	8.2	5	47	39	12.7	3	84	69	16.7	3	84	99	18.4	1	100
10	8.4	5	47	40	12.8	3	84	70	16.8	3	84	100	18.4	1	100
11	8.6	5	47	41	12.9	4	71	71	16.9	3	100	101	18.4	1	100
12	8.8	5	47	42	13.1	4	71	72	17.0	3	100	102	18.5	1	100
13	8.9	3	100	43	13.2	4	71	73	17.1	3	100	103	18.5	1	100
14	9.1	5	47	44	13.4	4	71	74	17.2	3	100	104	18.6	1	100
15	9.2	3	100	45	13.5	4	71	75	17.3	3	100	105	18.6	1	100

16	9.5	7	32	46	13.6	4	71	76	17.4	2	100	106	18.6	1	100
17	9.8	7	32	47	13.8	4	71	77	17.4	2	100	107	18.6	1	100
18	10.0	7	32	48	13.9	4	71	78	17.5	2	100	108	18.7	1	100
19	10.3	7	32	49	14.1	4	71	79	17.5	2	100	109	18.7	1	100
20	10.6	7	32	50	14.2	4	71	80	17.6	2	100	110	18.7	1	100
21	10.7	2	100	51	14.3	4	71	81	17.7	2	100	111	18.7	1	100
22	10.7	2	100	52	14.5	4	71	82	17.7	2	100	112	18.8	1	100
23	10.8	2	100	53	14.6	4	71	83	17.8	2	100	113	18.8	1	100
24	10.8	2	100	54	14.8	4	71	84	17.8	2	100	114	18.9	1	100
25	10.9	2	100	55	14.9	4	71	85	17.9	2	100	115	18.9	1	100
26	11.0	4	71	56	15.0	4	71	86	17.9	1	100	116	18.9	1	100
27	11.2	4	71	57	15.2	4	71	87	18.0	1	100	117	18.9	1	100
28	11.3	4	71	58	15.3	4	71	88	18.0	1	100	118	19.0	1	100
29	11.5	4	71	59	15.5	4	71	89	18.1	1	100	119	19.0	1	100
30	11.6	4	71	60	15.6	4	71	90	18.1	1	100	120	19.0	1	100

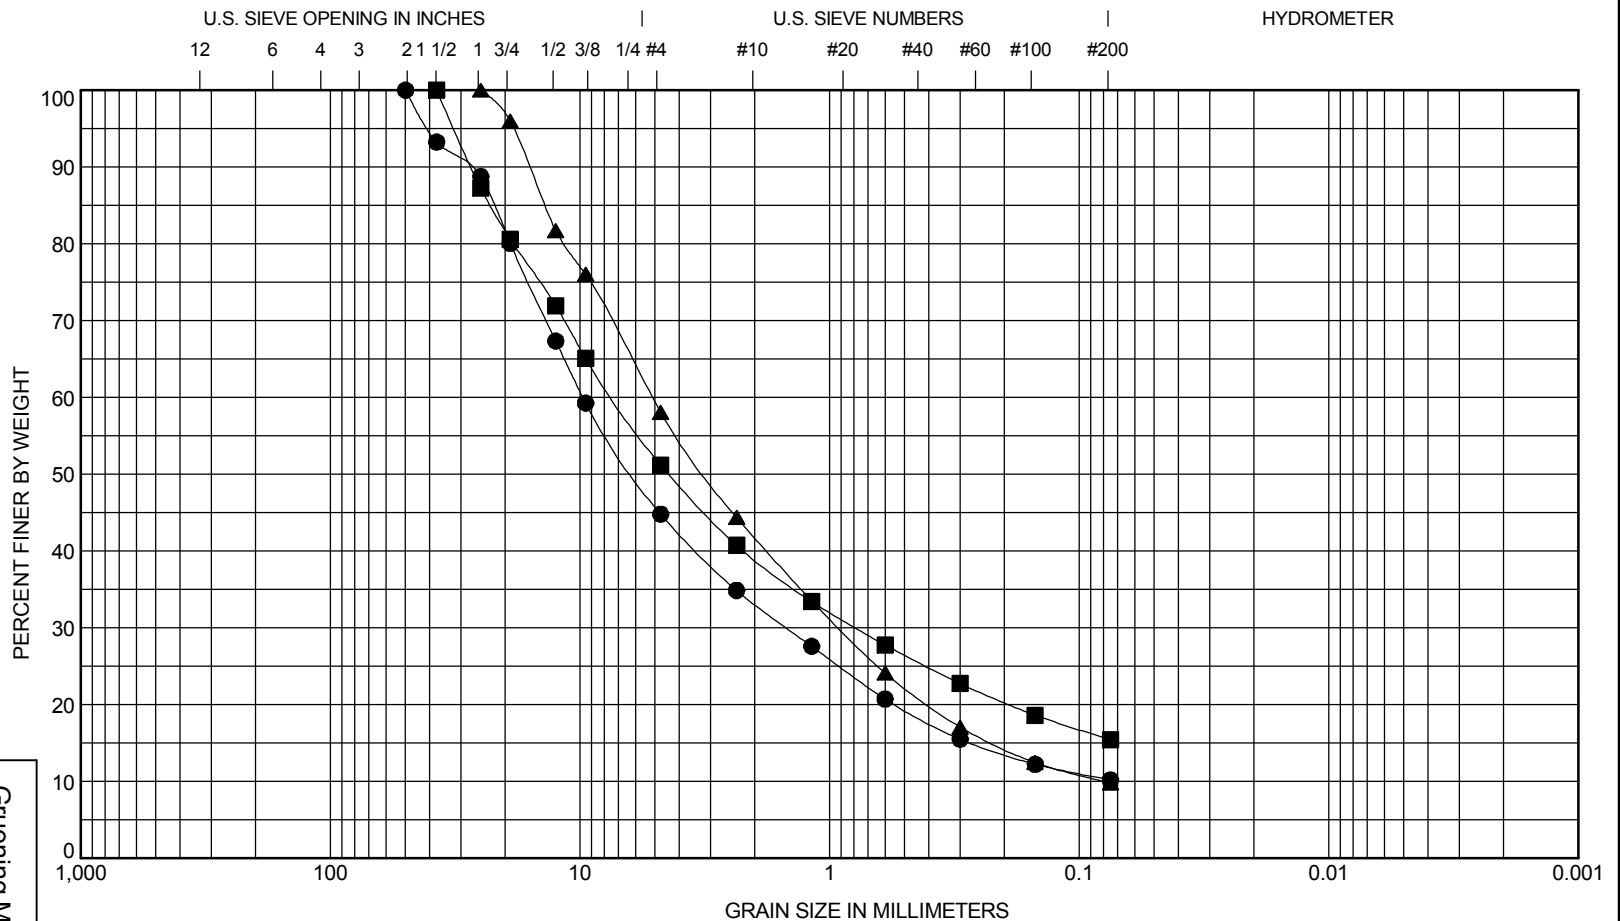
GRAVEL		SAND			SILT OR CLAY				
		coarse	fine	coarse	medium	fine					
Sample	Depth, Ft	Classification					LL	PL	PI	Cc	Cu
● B-03 S1	0.0 - 1.5	Poorly Graded Gravel with Silt and Sand (GP-GM)								3.2	138.3
■ B-03 S3	5.0 - 6.5	Silty Gravel with Sand (GM)									
▲ B-04 S3	5.0 - 6.5	Well-Graded Sand with Silt and Gravel (SW-SM)								2.1	64.5
Sample	Depth, Ft	D100	D60	D30	D10	%Gravel	%Sand	%Silt		%Clay	
● B-03 S1	0.0 - 1.5	50	9.74	1.49		55	35	10			
■ B-03 S3	5.0 - 6.5	37.5	7.38	0.78		49	36	15			
▲ B-04 S3	5.0 - 6.5	25	5.12	0.92	0.08	42	48	10

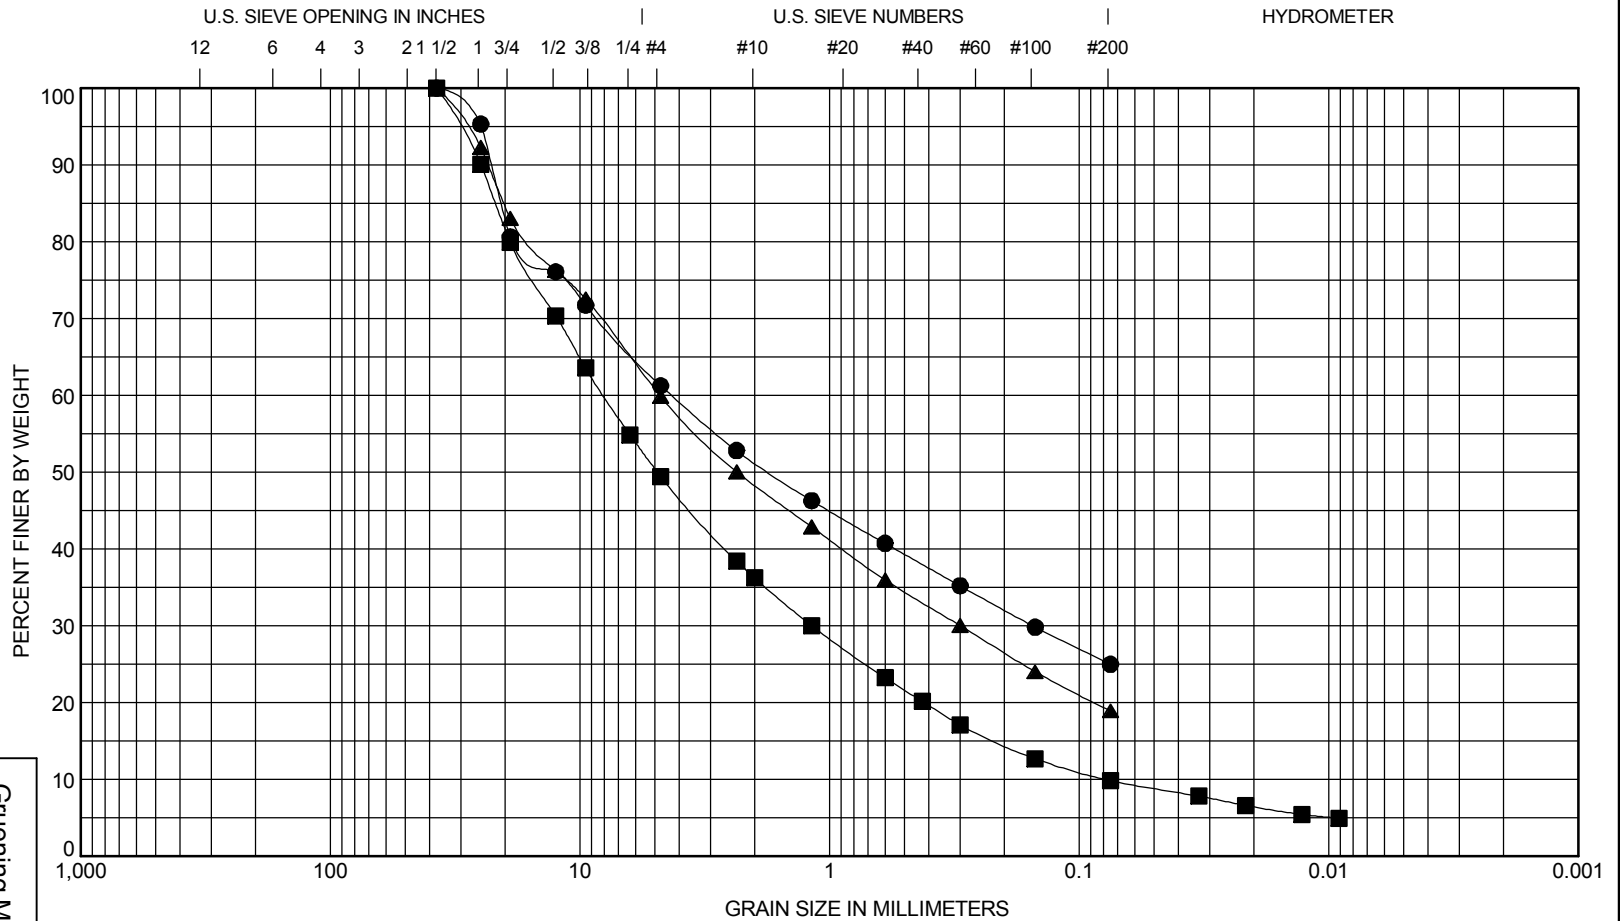
GRAVEL		SAND			SILT OR CLAY				
		coarse	fine	coarse	medium	fine					
Sample	Depth, Ft	Classification					LL	PL	PI	Cc	Cu
● B-04 S5	10.0 - 11.5	Silty Gravel with Sand (GM)									
■ B-05 S3	5.0 - 6.5	Well-Graded Gravel with Silt and Sand (GW-GM)								2.2	102.5
▲ B-05 S6	15.0 - 16.5	Silty Sand with Gravel (SM)									
Sample	Depth, Ft	D100	D60	D30	D10	%Gravel	%Sand	%Silt		%Clay	
● B-04 S5	10.0 - 11.5	37.5	4.28	0.15		39	36	25			
■ B-05 S3	5.0 - 6.5	37.5	8.03	1.18	0.08	51	40	10			
▲ B-05 S6	15.0 - 16.5	37.5	4.79	0.3		40	41	19

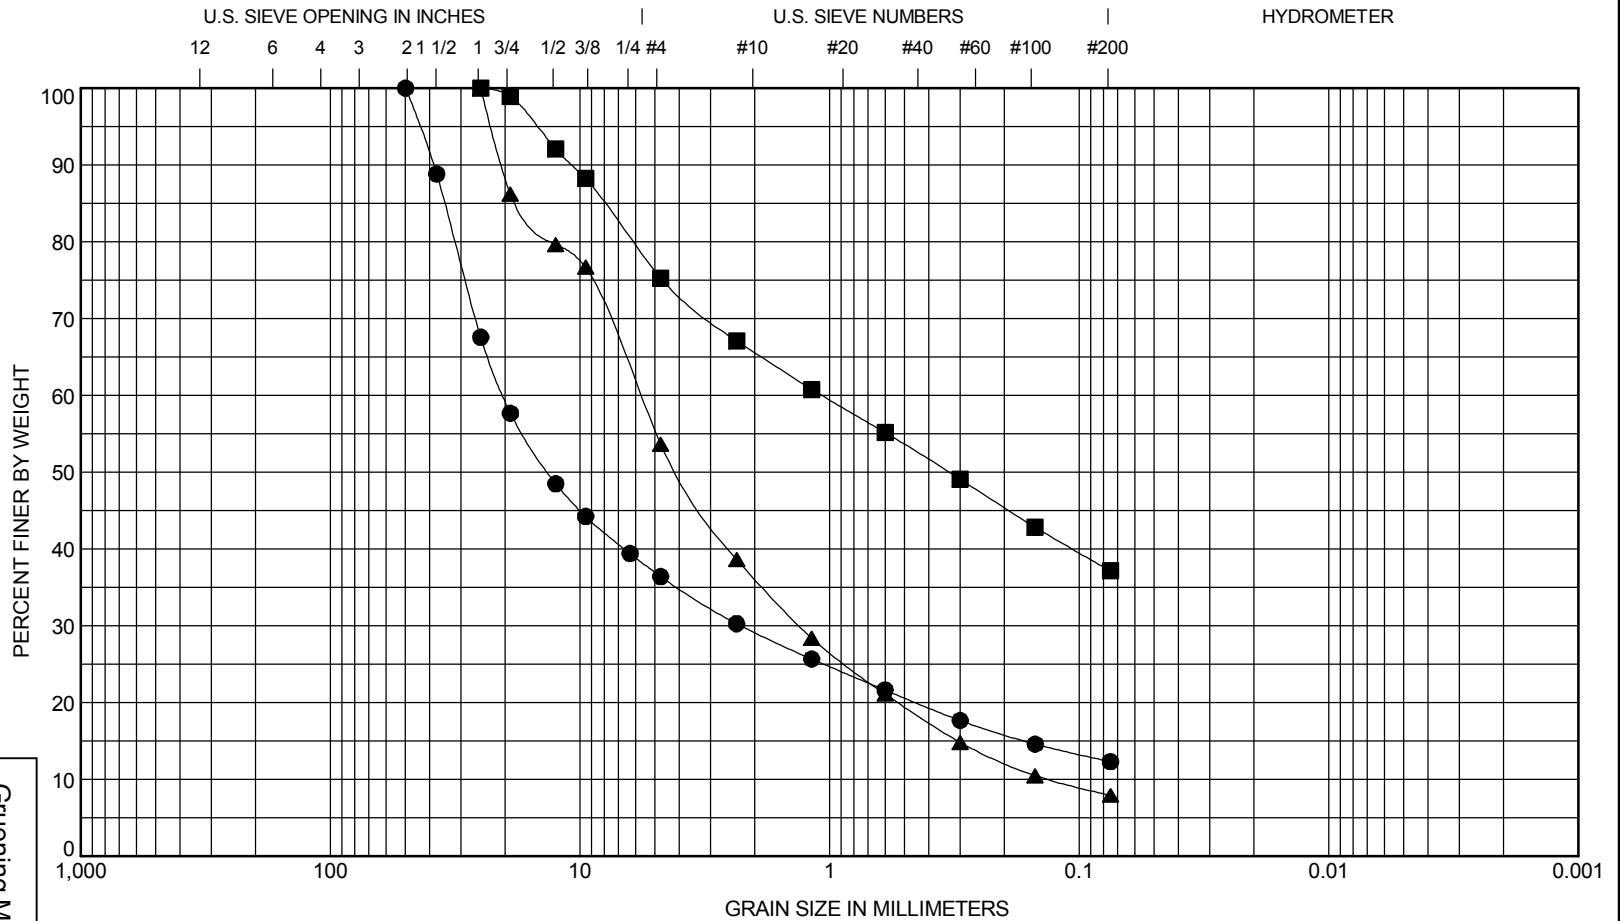
FIG. B-23  
Sheet 3 of 7

COBBLES			GRAVEL		SAND			SILT OR CLAY				
			coarse	fine	coarse	medium	fine					
Sample		Depth, Ft	Classification					LL	PL	PI	Cc	Cu
●	B-06 S1	0.0 - 1.5	Poorly Graded Gravel with Silt and Sand (GP-GM)								6.8	542.6
■	B-06 S4	7.5 - 9.0	Silty Sand with Gravel (SM)									
▲	B-07 S1A	0.4 - 1.9	Well-Graded Sand with Silt and Gravel (SW-SM)								2.3	43.6
Sample		Depth, Ft	D100	D60	D30	D10	%Gravel	%Sand	%Silt		%Clay	
●	B-06 S1	0.0 - 1.5	50	20.27	2.27		64	24	12			
■	B-06 S4	7.5 - 9.0	25	1.07			25	38	37			
▲	B-07 S1A	0.4 - 1.9	25	5.75	1.32	0.13	46	46	8
