**Geotechnical Engineering Report  
Gruening Middle School Earthquake Repairs  
Eagle River, Alaska**

**GEOTECHNICAL ENGINEERING REPORT  
GRUENING MIDDLE SCHOOL EARTHQUAKE REPAIRS  
EAGLE RIVER, ALASKA**

## **GEOTECHNICAL EVALUATION OF GRUENING MIDDLE SCHOOL FOUNDATION EARTHQUAKE DAMAGE, EAGLE RIVER, ALASKA**

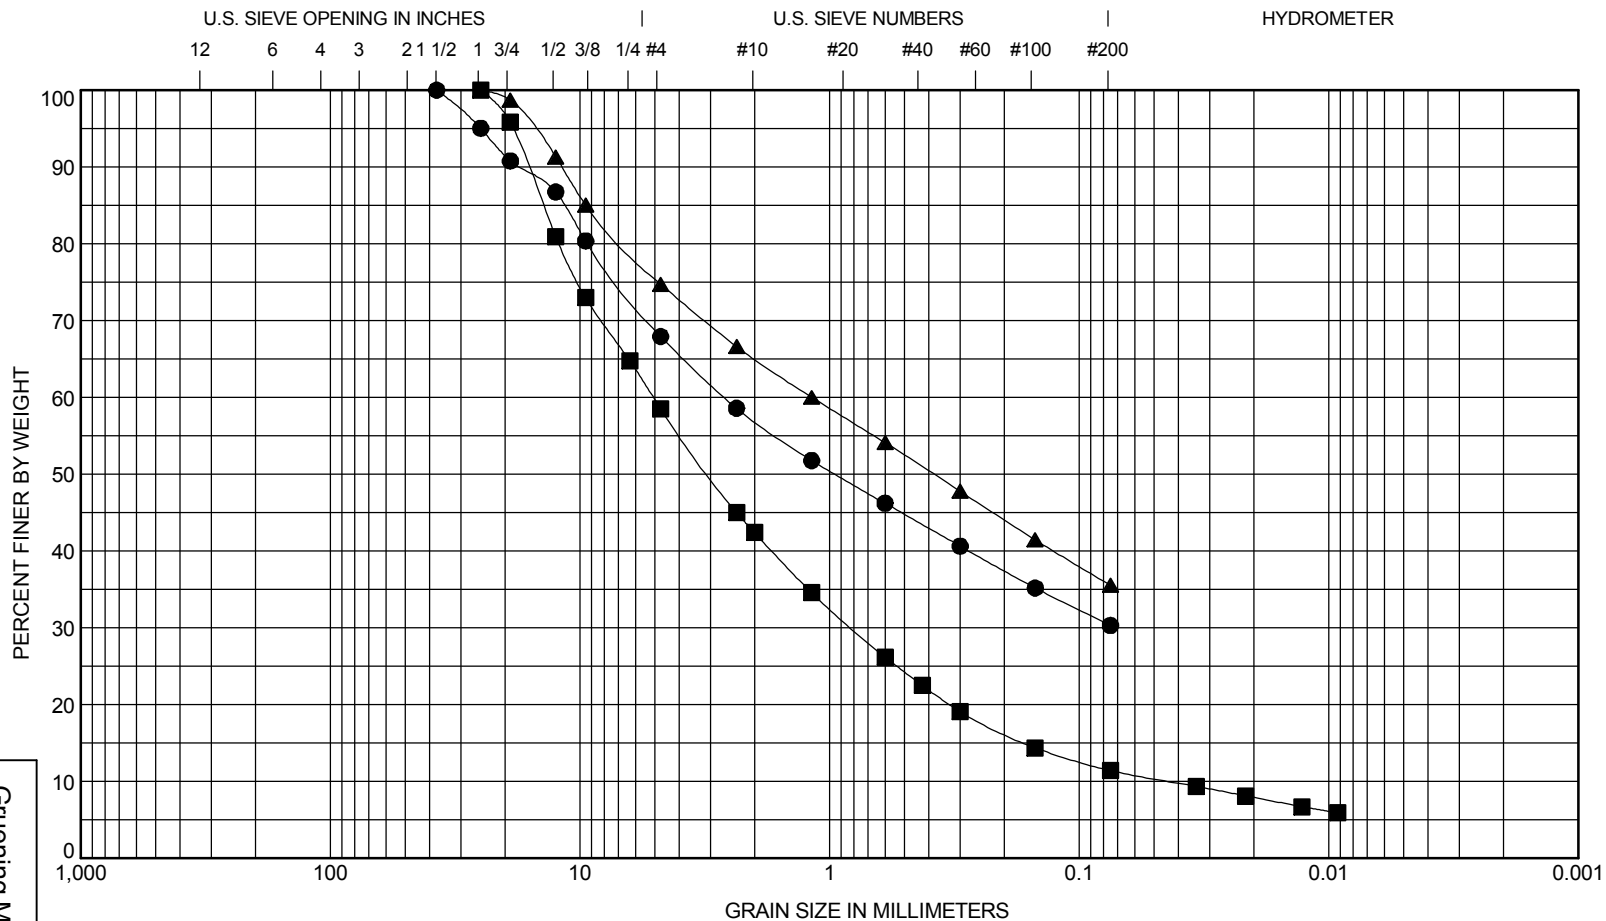
FIG. B-23  
Sheet 4 of 7

GRAVEL		SAND			SILT OR CLAY				
		coarse	fine	coarse	medium	fine					
Sample	Depth, Ft	Classification					LL	PL	PI	Cc	Cu
● B-07 S4	7.5 - 9.0	Silty Sand with Gravel (SM)									
■ B-08 S2	2.5 - 4.0	Well-Graded Sand with Silt and Gravel (SW-SM)								3.0	116.1
▲ B-08 S5	10.0 - 11.5	Silty Sand with Gravel (SM)									
Sample	Depth, Ft	D100	D60	D30	D10	%Gravel	%Sand	%Silt		%Clay	
● B-07 S4	7.5 - 9.0	37.5	2.62			32	38	30			
■ B-08 S2	2.5 - 4.0	25	5.09	0.82	0.04	42	47	11			
▲ B-08 S5	10.0 - 11.5	25	1.18			25	39	36

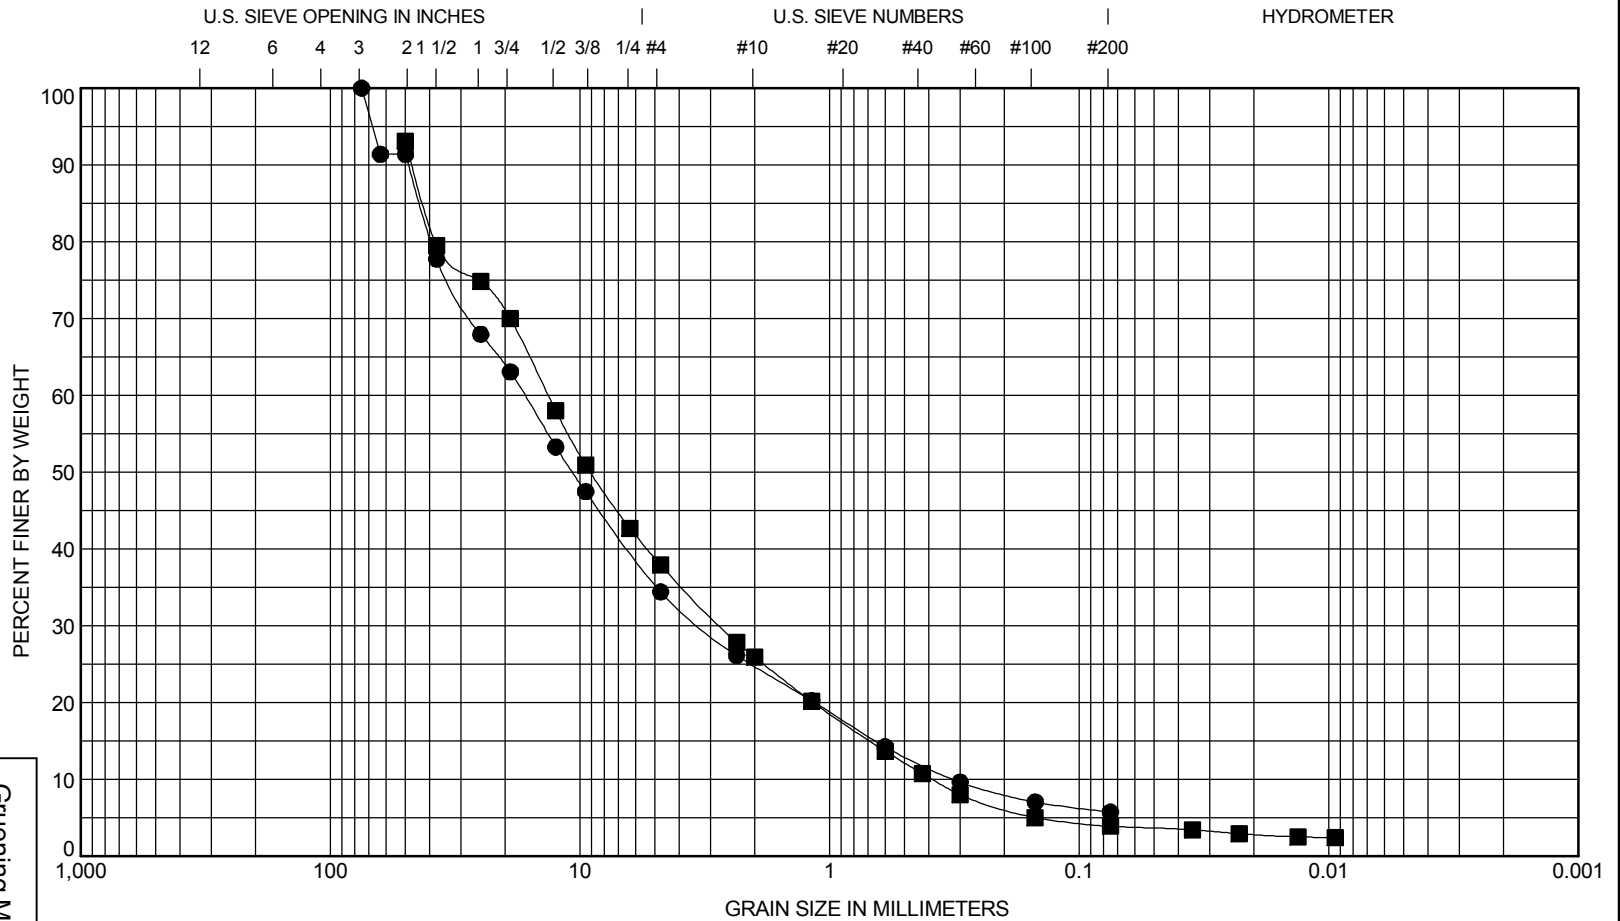
COBBLES		GRAVEL		SAND			SILT OR CLAY				
		coarse	fine	coarse	medium	fine					
Sample	Depth, Ft	Classification					LL	PL	PI	Cc	Cu
● TP-1 S3	3.8 - 5.3	Well-Graded Gravel with Silt and Sand (GW-GM)								2.0	52.6
■ TP-2 S3	5.8 - 6.2	Well-Graded Gravel with Sand (GW)								1.4	34.7
Sample	Depth, Ft	D100	D60	D30	D10	%Gravel	%Sand	%Silt		%Clay	
● TP-1 S3	3.8 - 5.3	75	16.67	3.27	0.32	66	29	6			
■ TP-2 S3	5.8 - 6.2	50	13.42	2.74	0.39	55	34	4
