### March 20, 2019

# GRUENING MIDDLE SCHOOL POST-EARTHQUAKE ASSESSMENTS AND EVALUATION

Prepared For: Anchorage School District Facilities Department 1301 Labar Street Anchorage, Alaska 99515

<u>Prepared By:</u> BDS Architects 3330 C Street, Suite 200 Anchorage, Alaska 99503

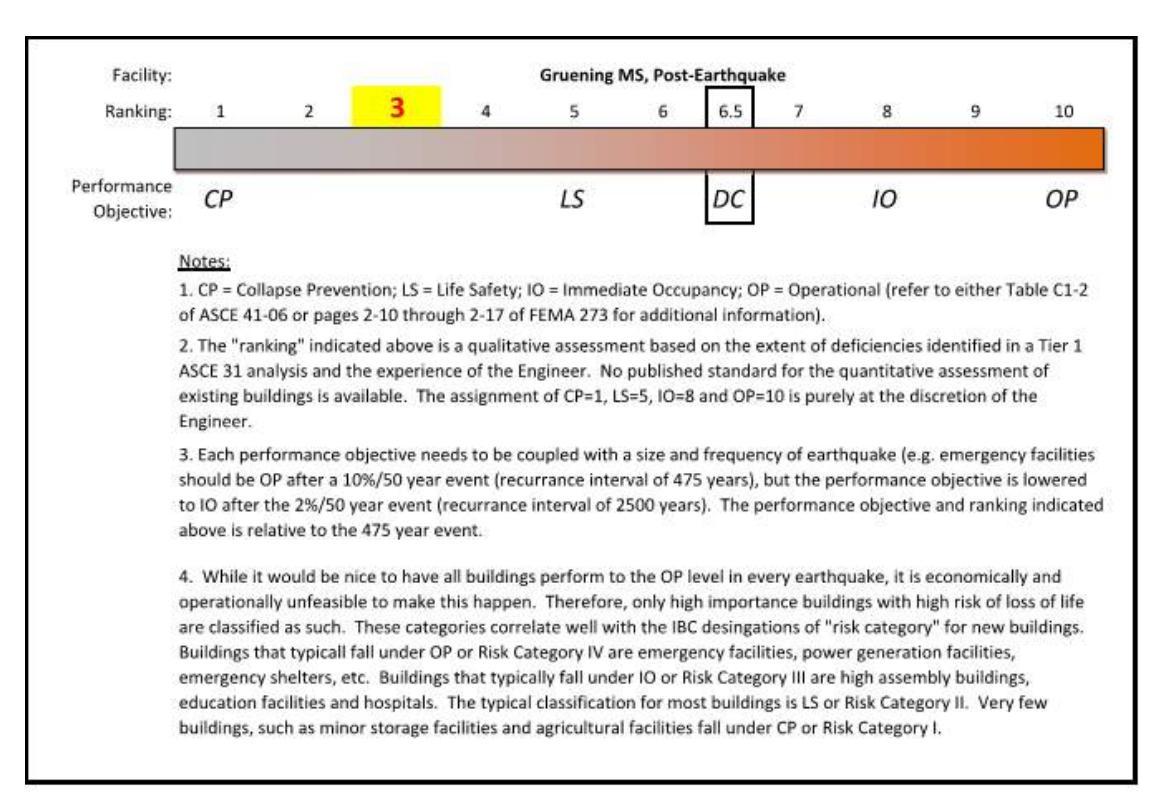
Figure 3: Qualitative Building Ranking

Following the November 30, 2018 M7.1 earthquake, the existing structure at Gruening Middle School was down-rated to a 3 on a scale of 1-10 due the amount of CMU cracking and the CMU wall separation from the roof diaphragm (see figure 3). The damage from the earthquake degraded this building's ability to provide a ductile response in a similar sized and located earthquake today.

This puts the building well below the Life Safety (LS) performance objective (5), and the target performance objective of Damage Control (DC, 6.5).

After the completion of all repairs and mitigations indicated in both the earthquake-related damage repairs and damage control improvements, the building could be re-rated to a 6.5.

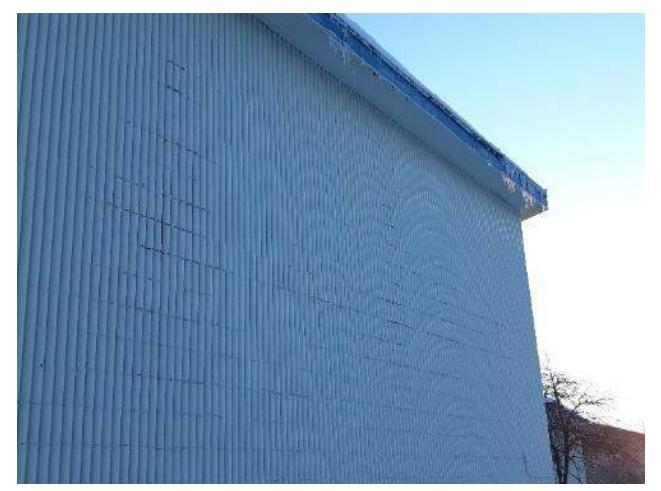
Photo 1-5: Northwest CMU Wall at Music Cassrooms

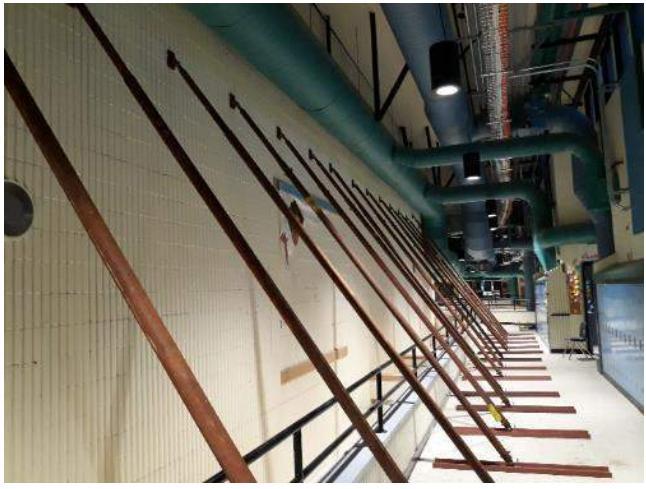
Photo 3-3: Wall Bracing at Displaced Gym/Corridor Wall

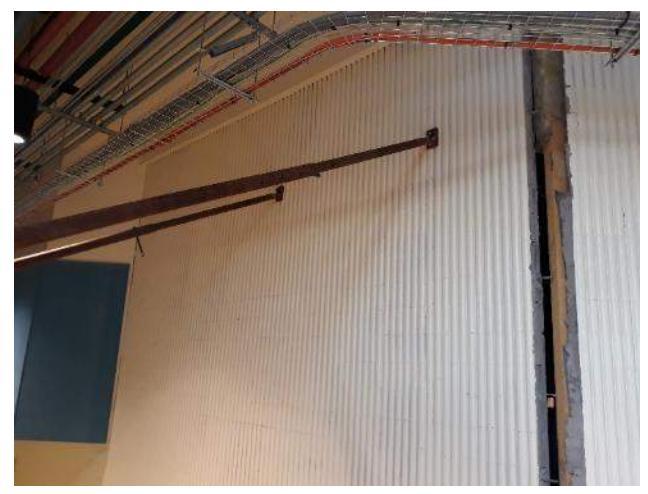
Photo 9-3: Temporary Wall Bracing at MPR Wall

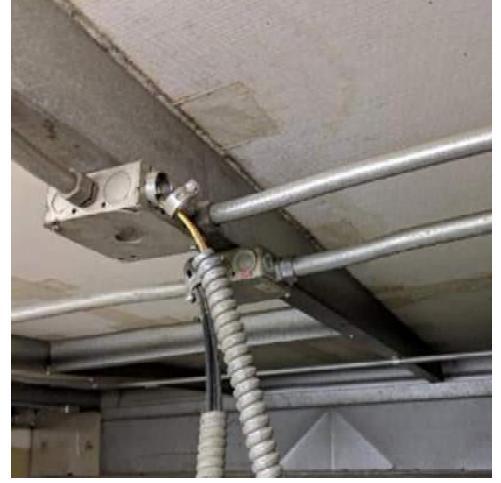
Photo 9-5: AHU Connection at Gymnasium

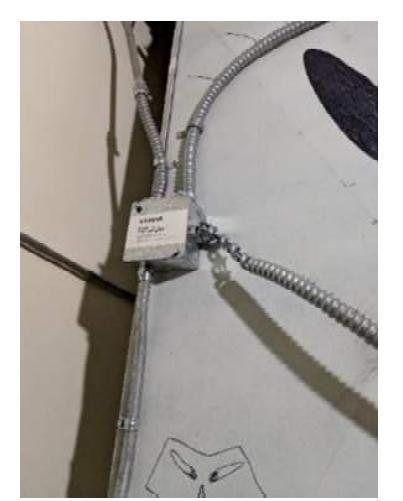
Photo 10-1: Mechanical Equipment Connection

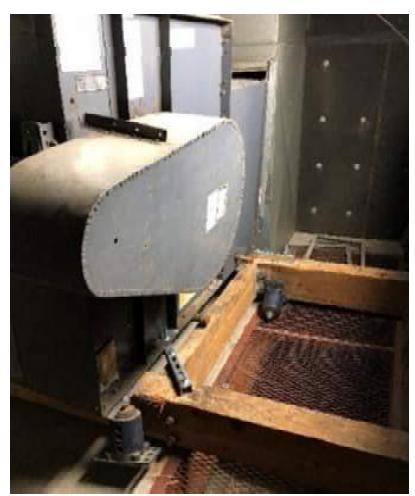
Photo 10-3: MPR Ventilation Unit 2

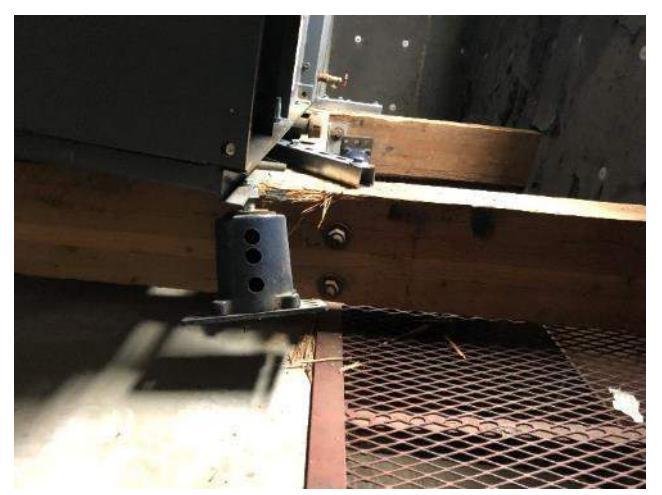
Photo 10-2: MPR Ventilation Unit 1

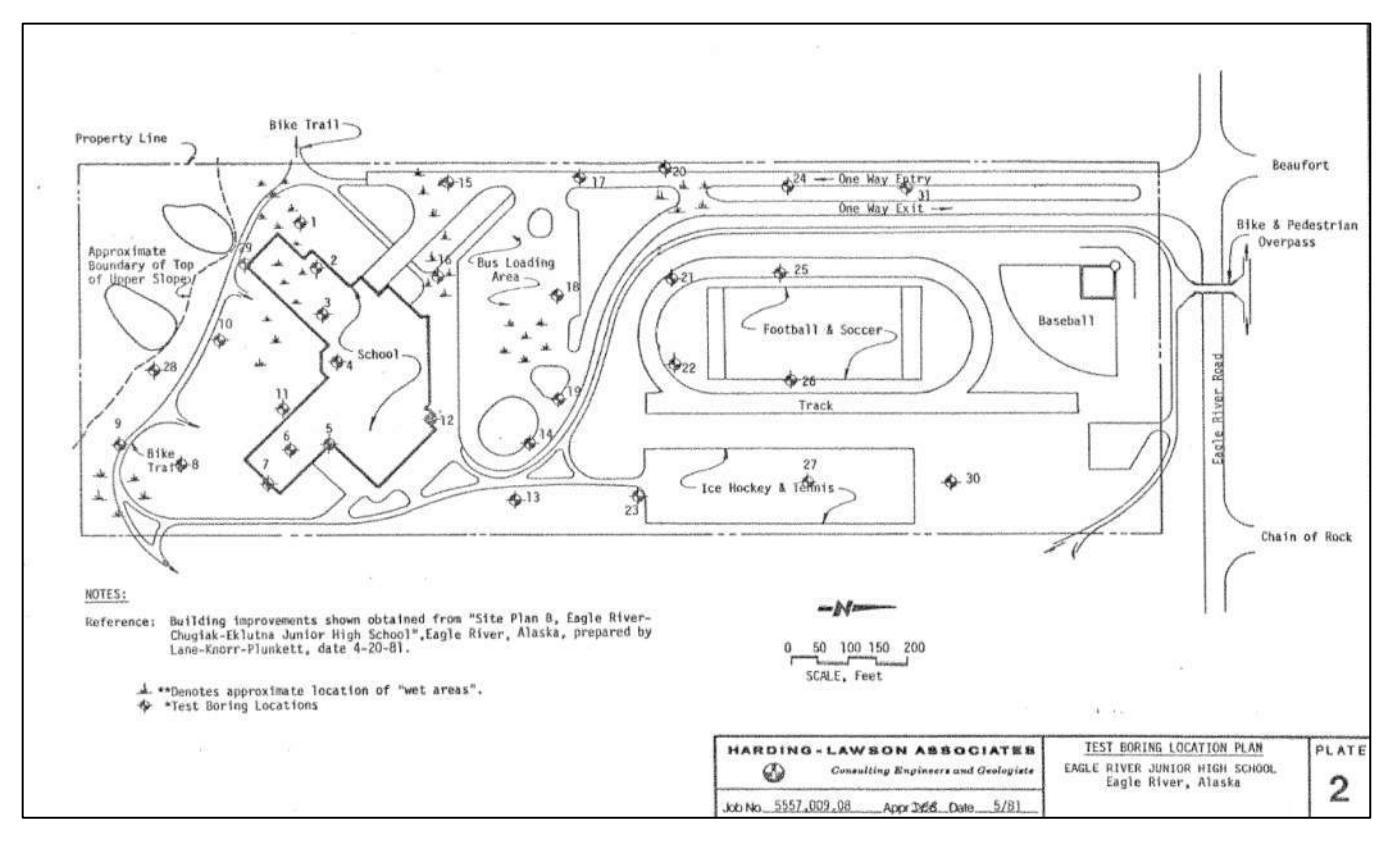
Figure 3.1: Borehole Location Map (HLA, 1981)

The geotechnical study (HLA, 1981) consisted of drilling and sampling test borings at the locations shown in Figure 2.1. Comparison of dimensions shown in Figure 3.1 indicate that the school building appears to be in approximately the same location and general shape as the existing building. One test boring (HLA Test Boring 12) is at the corner of the gymnasium at the location of the separated stairwell. Other site features of note are ponded surface water observed by HLA around the building footprint, indicated as 'wet areas' by HLA in Figure 3.1.

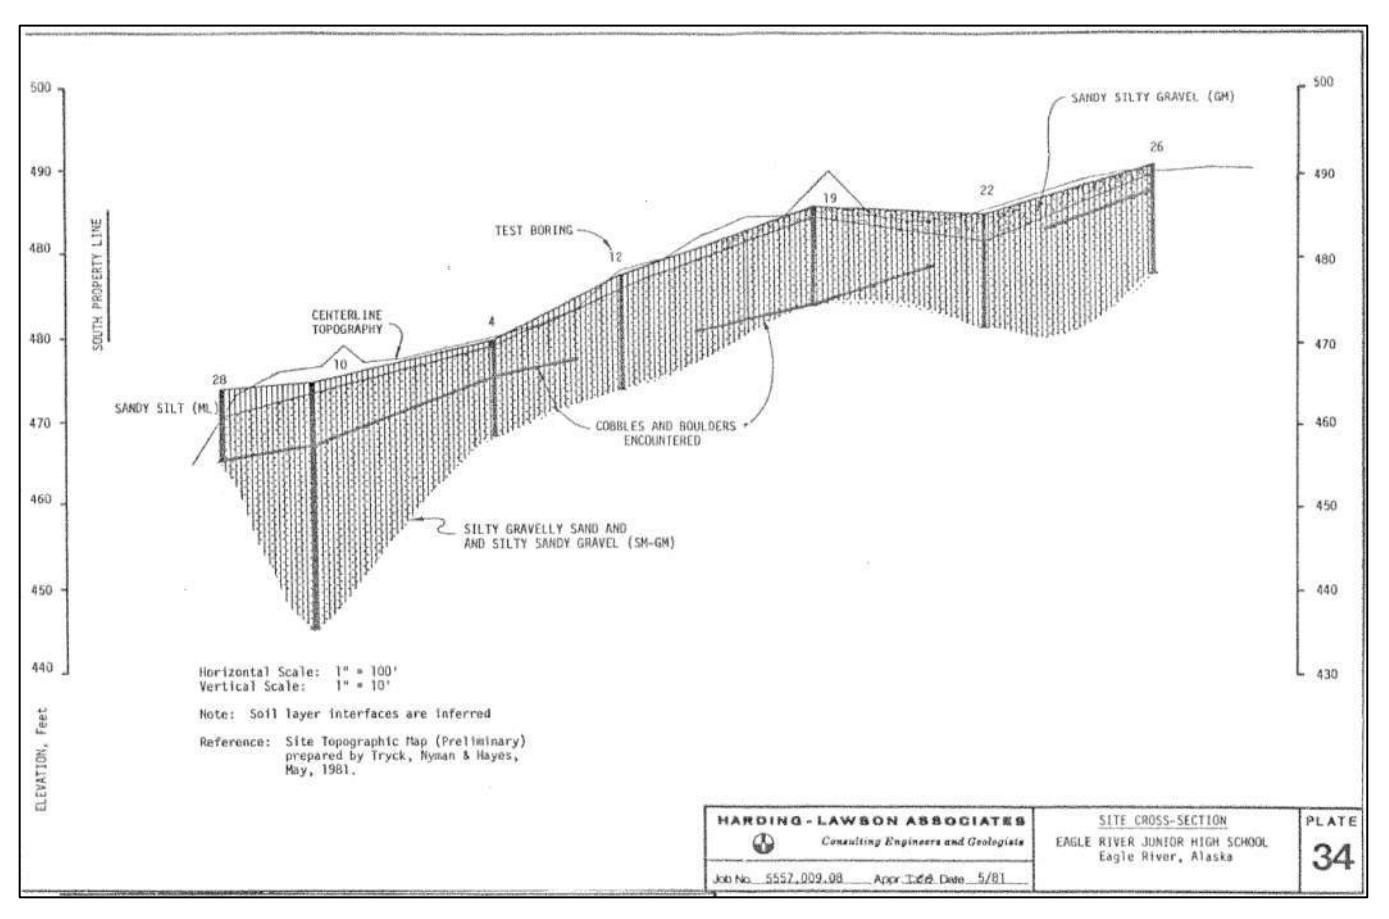
Figure 3.2: Cross Section Showing Generalized Subsurface Conditions (HLA, 1981)

The data obtained by HLA indicates relatively consistent subsurface conditions, generally characterized as a dense silty gravel with sand below a near surface layer of sandy silt (Figure 3.2). Boulders and cobbles were encountered in the boreholes. Groundwater was encountered in five of the 31 boreholes at the time of drilling. Groundwater was generally observed ranging from 10 to 20 feet below ground surface (bgs) at the time of drilling. One borehole, HLA Test Boring 22, encountered water at three feet bgs at the time of drilling, but groundwater was measured to be 16 feet bgs three weeks after completion of drilling.
